# Commemorating the 100-Year Anniversary of the June 29, 1925 Santa Barbara Earthquake

*What We Learned After the Shaking Stopped*

Larry D. Gurrola, Ph.D.

*June 9, 2025*

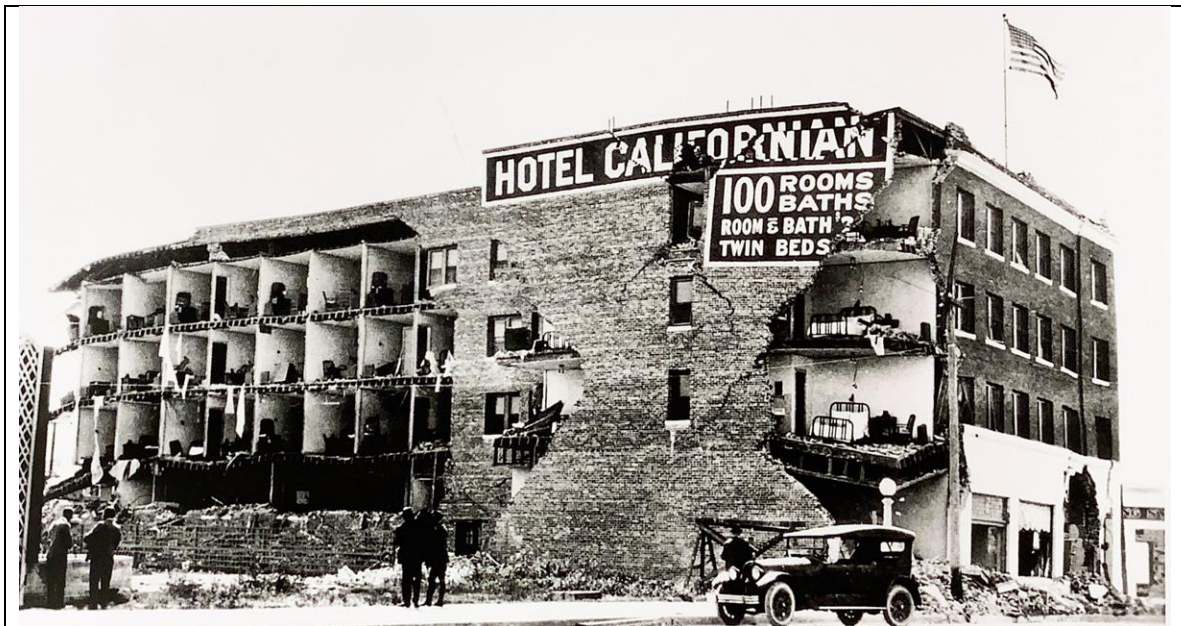
The Californian Hotel located at 35 State Street had opened for business less than two weeks prior to the earthquake and was the newest hotel in the city at the time (The Morning Press, June 30, 1925). The damage was described as a total loss (Figures 4, 5, 6, and 7). The first shock caused the walls to bulge out and three following shocks caused the wall to topple onto the sidewalk and street. The floors remained but the north and south walls had collapsed, and the hotel rooms were exposed. A woman fell out of the fourth-floor hotel and miraculously, she slid down to the ground falling on a man's shoulders. Neither of them was injured. A couple were thrown out of their second-floor room by the force of the shock and fell to the ground. Except for bruises and scratches, they were uninjured (The Morning Press, June 30, 1925).

Figure 4. View of the west side of the four-story Hotel Californian. The walls collapsed outward and constructed with exterior walls of concrete encased structural steel columns and beams that surround brick panels (Sylvester and Mendes, 2011). Photo credit: Santa Barbara Historical Museum, Gledhill Library.

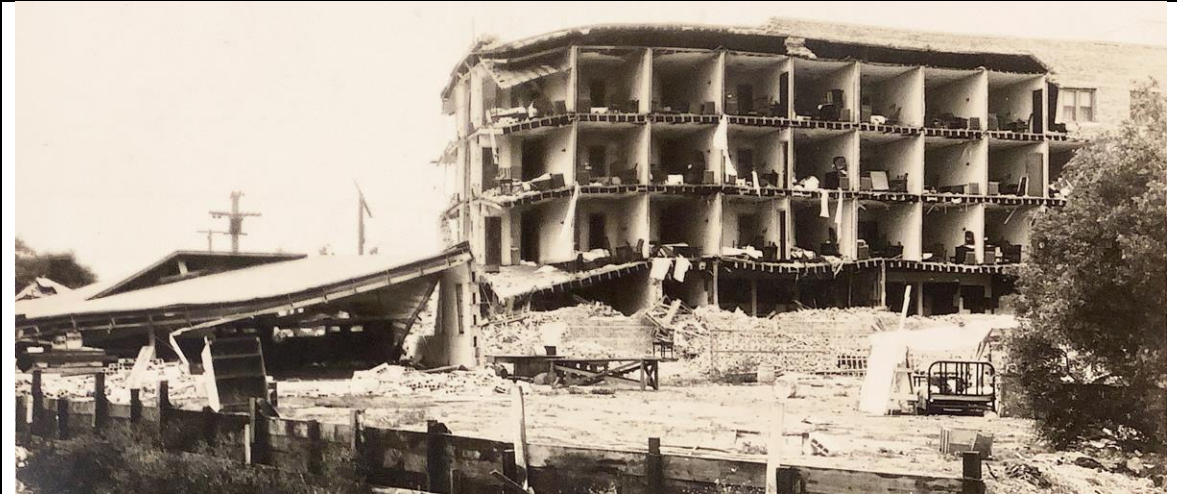
Figure 5. View of the east side of the Hotel Californian and the adjacent garage structure shown on the lower left of the photograph. Photo credit: Santa Barbara Historical Museum, Gledhill Library.

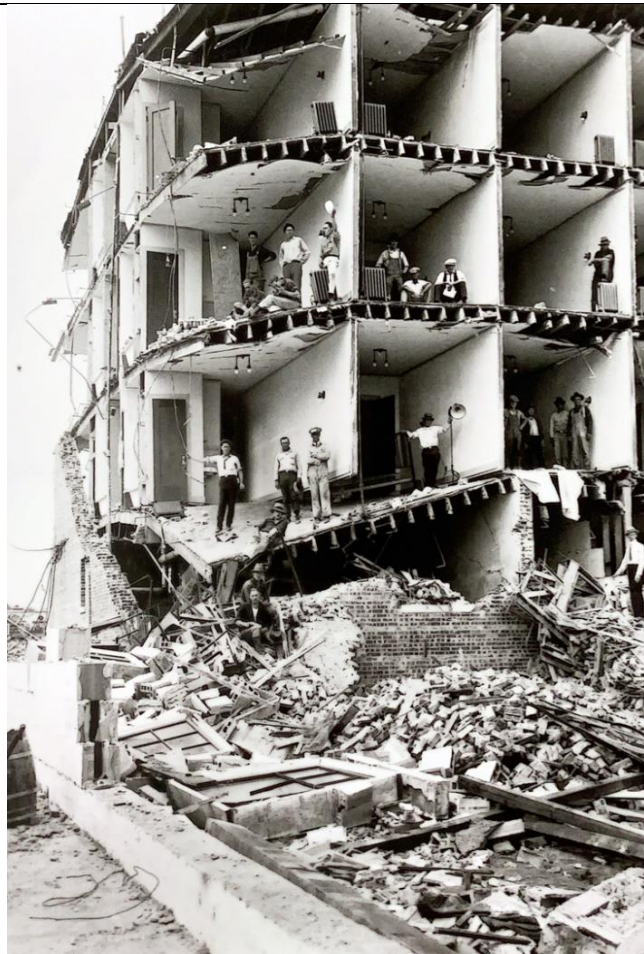
Figure 6. Close-up view of the east side of the Hotel Californian with workers clearing debris from the structure. Photo credit: Santa Barbara Historical Museum, Gledhill Library.

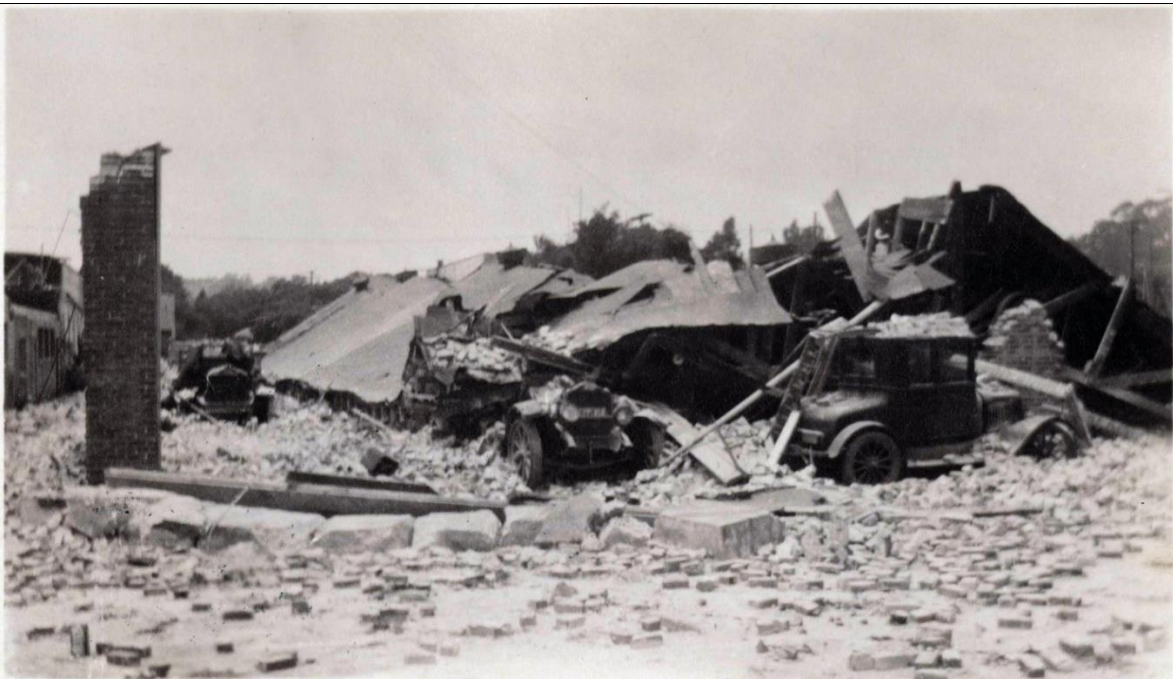
Western Motors Transfer Co.

Four employees of the Western Motors Transfer Company (Figure 8) worked in a building on State Street that collapsed with the first shock of the earthquake (The Morning Press, June 30, 1925). They didn't have time to clear out of the building and suffered minor to major injuries. A fifth employee was seriously injured and not expected to survive. The building was located 116-118 State Street in the lower downtown area.

Figure 8. The complete collapse of the Western Motors Transfer building which was located at 116-118 State Street.

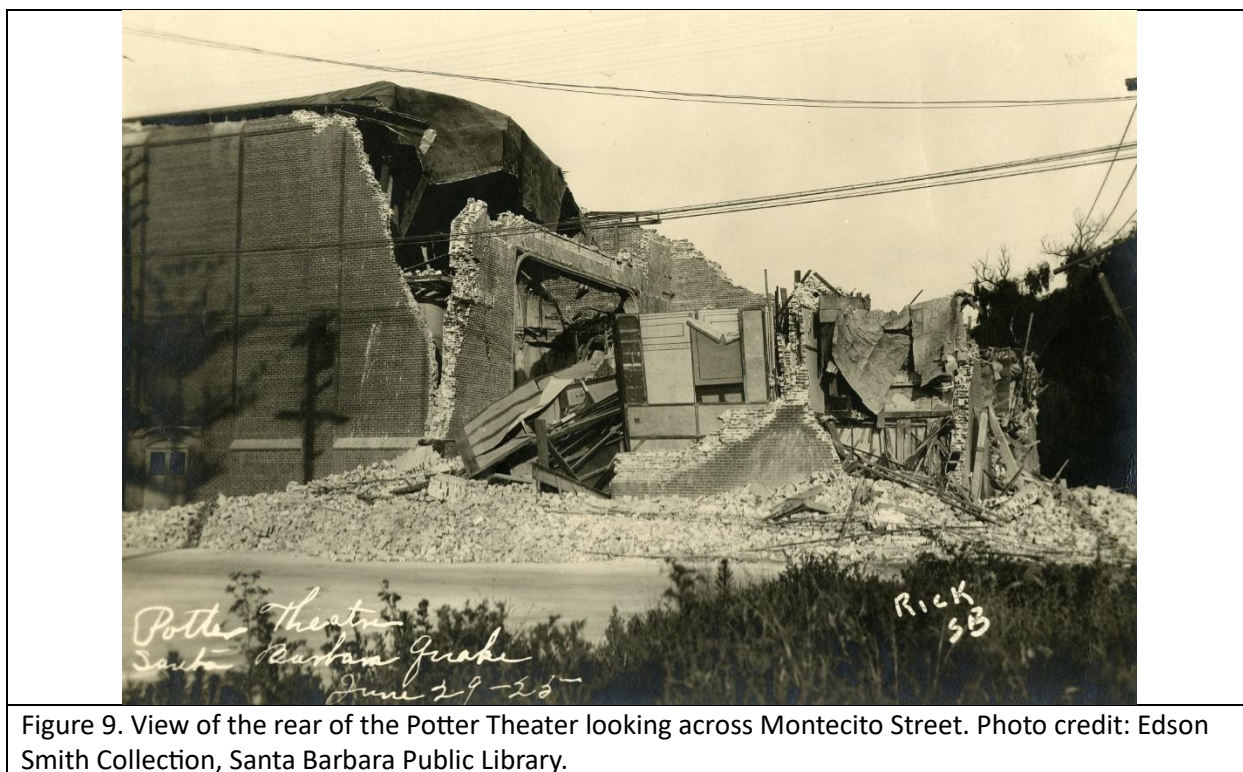
Figure 9. View of the rear of the Potter Theater looking across Montecito Street. Photo credit: Edson Smith Collection, Santa Barbara Public Library.

rear portion was shoved outward by the heavy brick walls. The garage at the rear of the building completely pancaked flat.

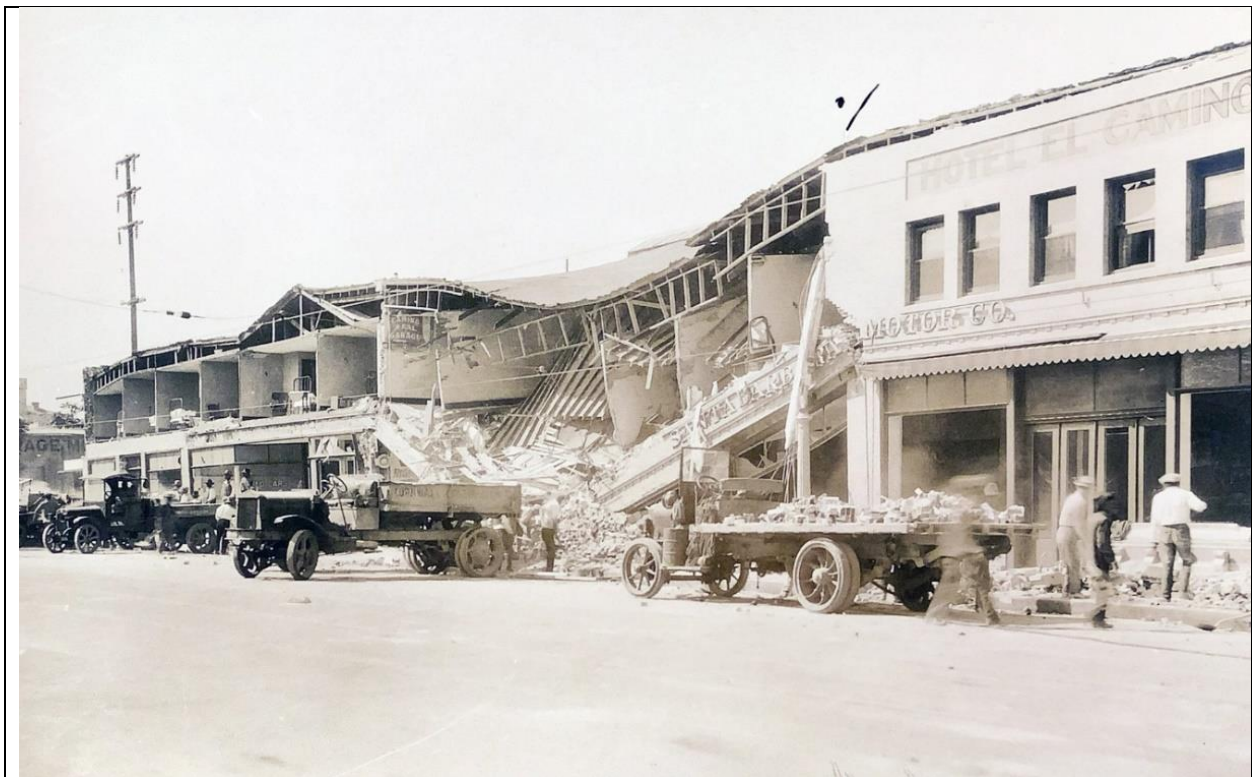
The auto district was comprised of several auto showrooms that were severely damaged. Nearly the entire block of the auto district was considered a complete loss (Figure 11.) Auto row as it was called was located on the 300 block of State Street. The Hotel Barbara was located on State Street and Cota Street, and although all the brick had fallen off the first story walls, not a crack appeared on the walls of the three floors above (The Morning Press, June 30, 1925). The southwest corner of the building collapsed but the remainder of the building was left intact.

Figure 11. Auto row was destroyed by the earthquake as seen in the photograph where the partial collapse of second story lodging fell in the auto showrooms below. Photo credit: Santa Barbara Historical Museum, Gledhill Library.

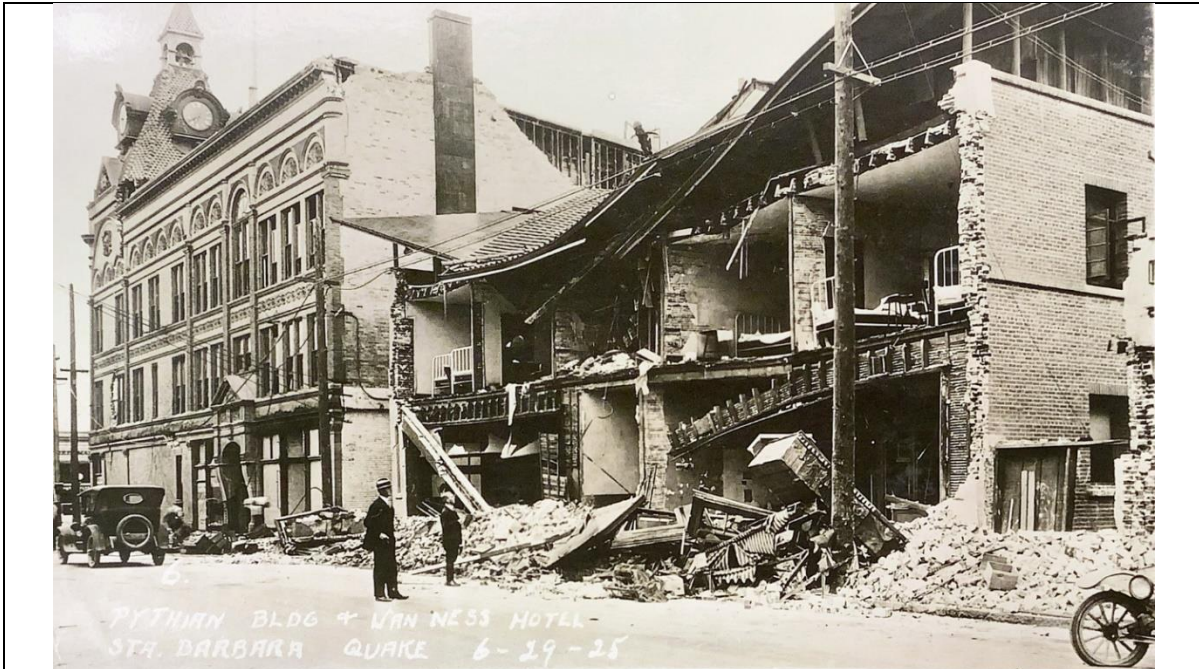
An attorney who was working in the Fithian building (Figure 12) when the earthquake occurred and he narrowly escaped when the earthquake struck (The Morning Press, July 1, 1925). He initially thought the building had been dynamited and jumped up to grab hold of the door frame to stop from falling. He didn't remember how he reached the street and recalled that building after building dropped to the ground. Next door to the Fithian building, the street-side wall of the Van Ness Hotel (Figure 12) toppled, and two bodies were reported buried in the debris (The Morning Press, June 30, 1925; July 1, 1925). The Van Ness Hotel was a three-story brick masonry constructed building. The Fithian building located at the southeast corner of

Figure 12. The Van Ness Hotel with a collapsed wall and roof sits next to the Fithian Building. The brick masonry wall of the Fithian Building in the upper center of the photograph has collapsed. Photo credit: Santa Barbara Historical Museum, Gledhill Library.

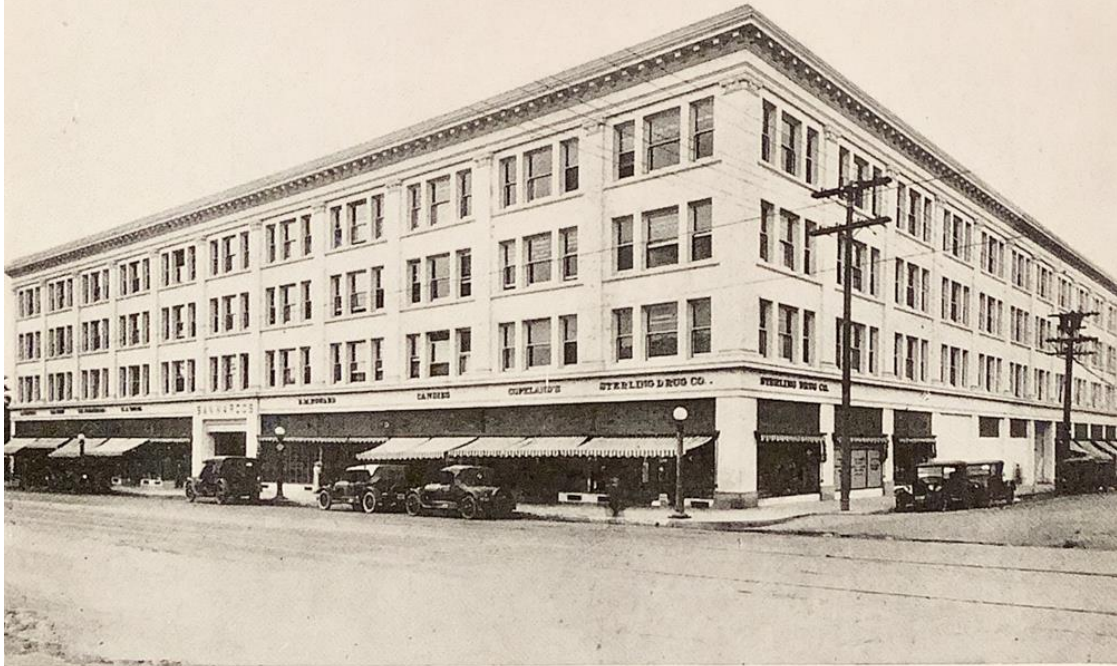
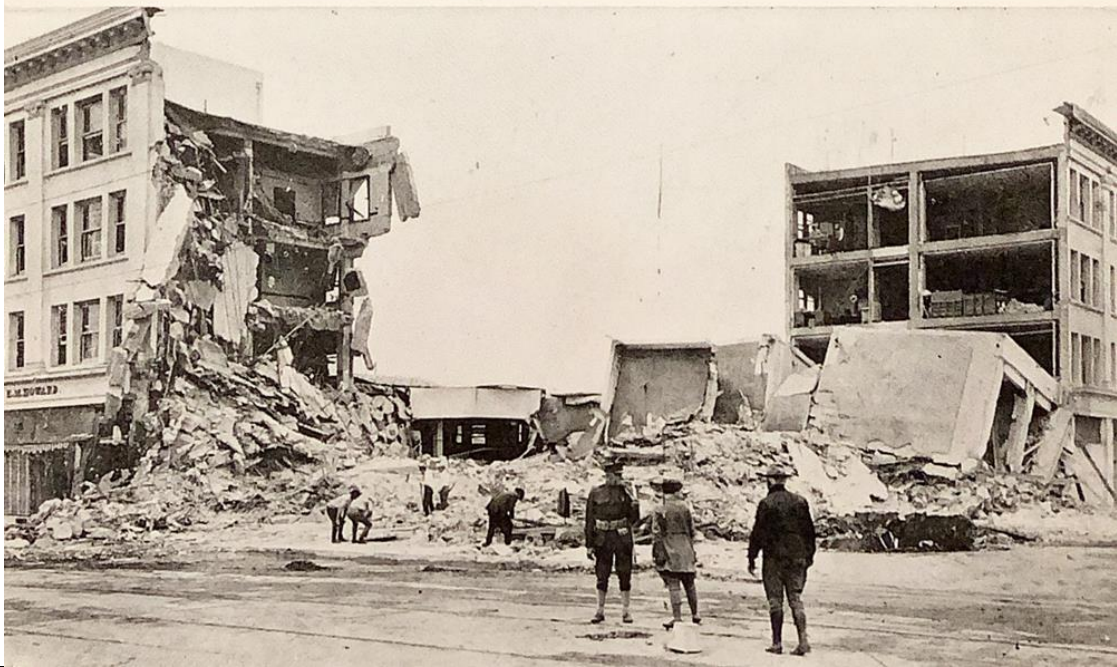
Santa Barbara Earthquake, 6-29-25. San Marcos Bldg. — *Before and After*

Figure 13. Postcard photographs of before and after the earthquake of the four-story San Marcos Building. Sylvester and Mendes (2001) note that the building was constructed in several sections that were not structurally tied together, and they suggest that battering of the two wings occurred during the shaking. Two people were killed in the collapse of the building. Only one wing of the building was rebuilt and it is now a two-story building. The San Marcos building is located on the southeast corner of State Street and Anapamu Street. Photo credit: Santa Barbara Historical Museum, Gledhill Library.

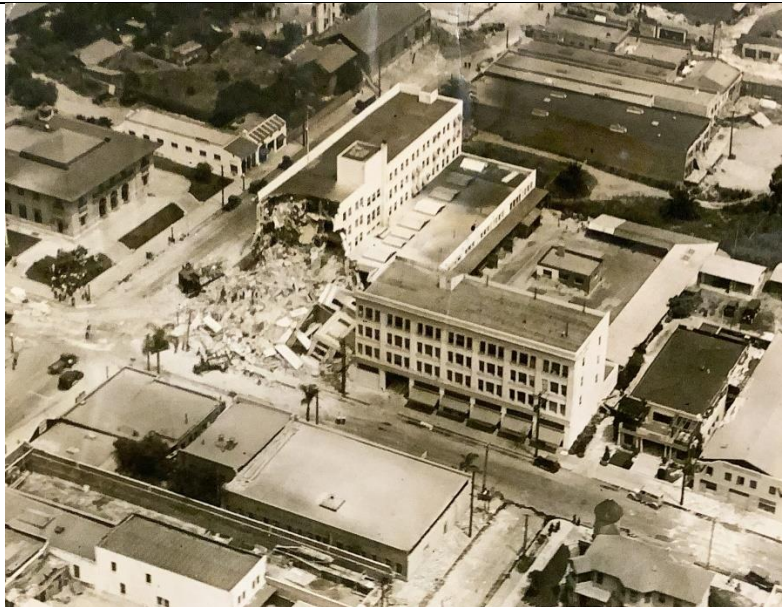
Figure 14. Aerial view of the severely damaged San Marcos Building. The street the runs from the left center to the top center of the photograph is State Street. The cross street is Anapamu Street. Photo credit: Santa Barbara Historical Museum, Gledhill Library.

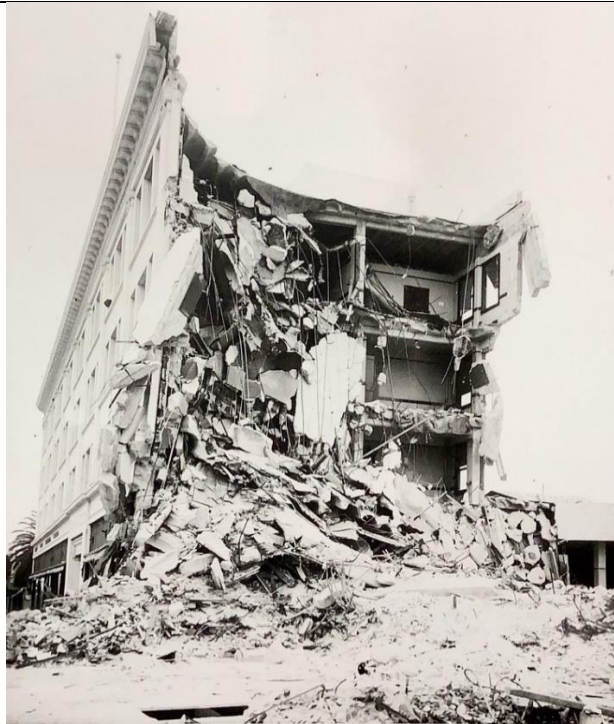
Figure 15. View of the destruction of the east wing of the San Marcos Building. State Street is on the left side of the building. Photo credit: Santa Barbara Historical Museum, Gledhill Library.

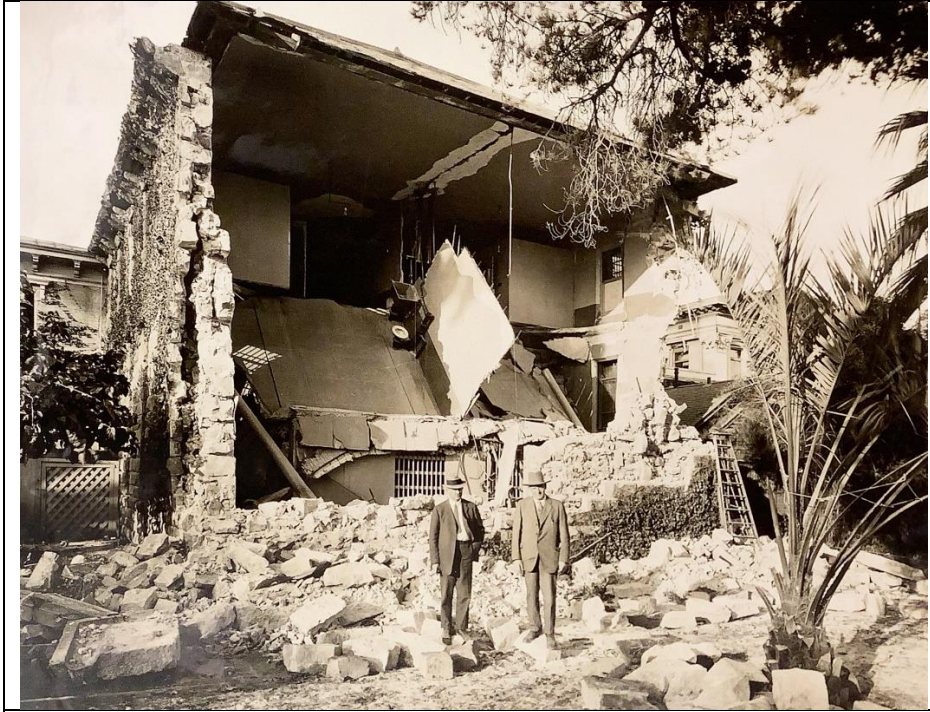
The shaking of the earthquake caused the collapse of the east wall and the second floor of the county jail (Figure 16) (The Morning Press, June 30, 1925). The prisoners were reportedly in shock and immediately removed from the building. Most of the prisoners held on minor charges were paroled.

Figure 16. The unreinforced stone masonry structure of the County jail was severely damaged. Standing in front was Supervisor Sam Stanwood (left) and Sheriff Jim Ross (right). Note the collapsed second story floor inside the structure. Photo credit: Santa Barbara Historical Museum, Gledhill Library.

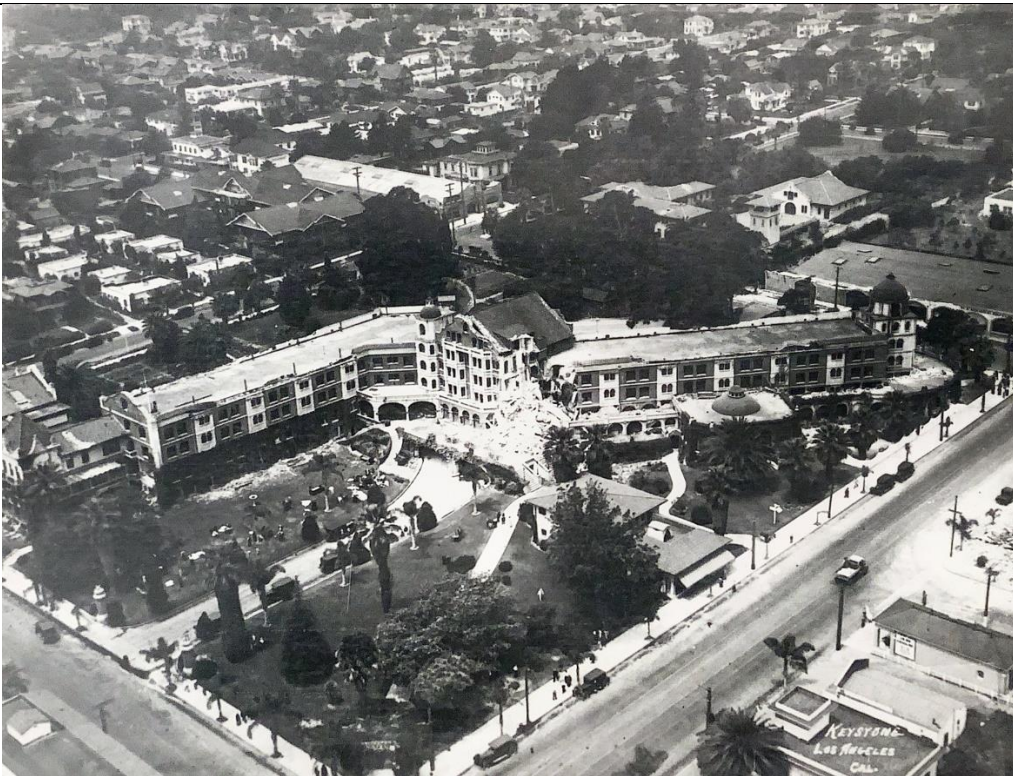
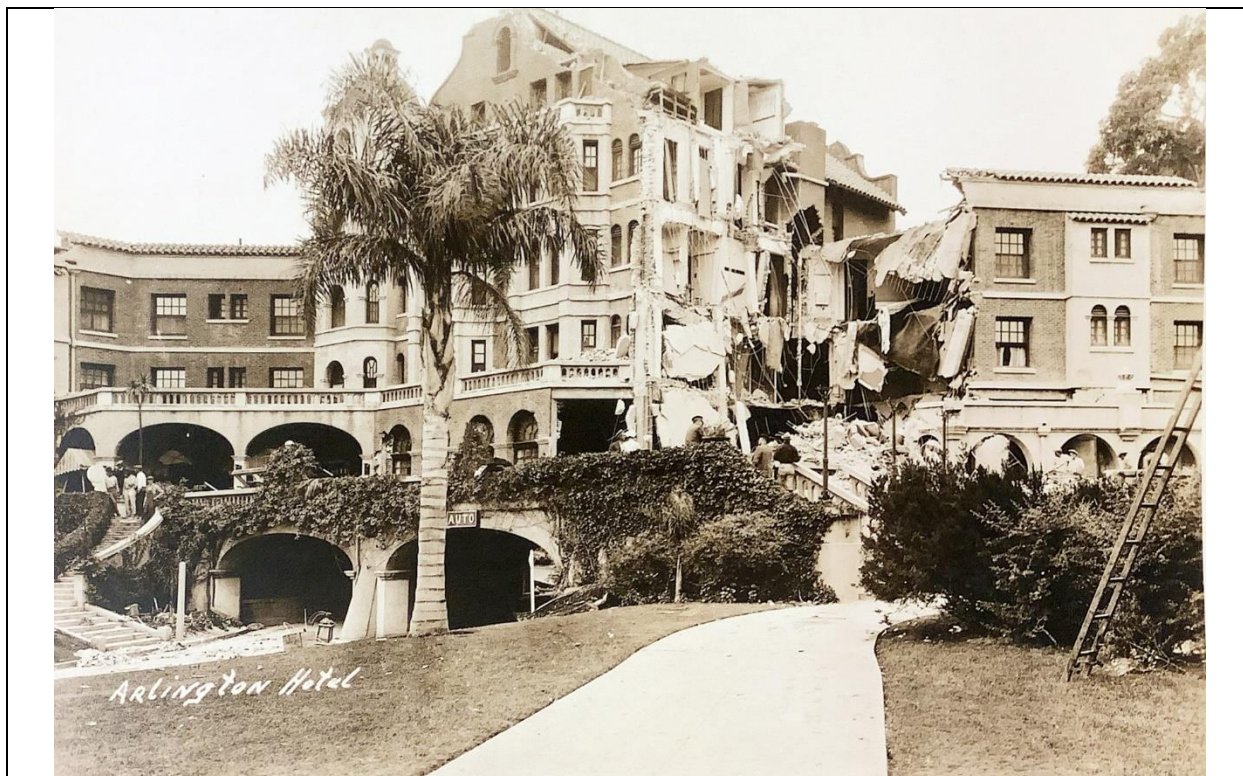
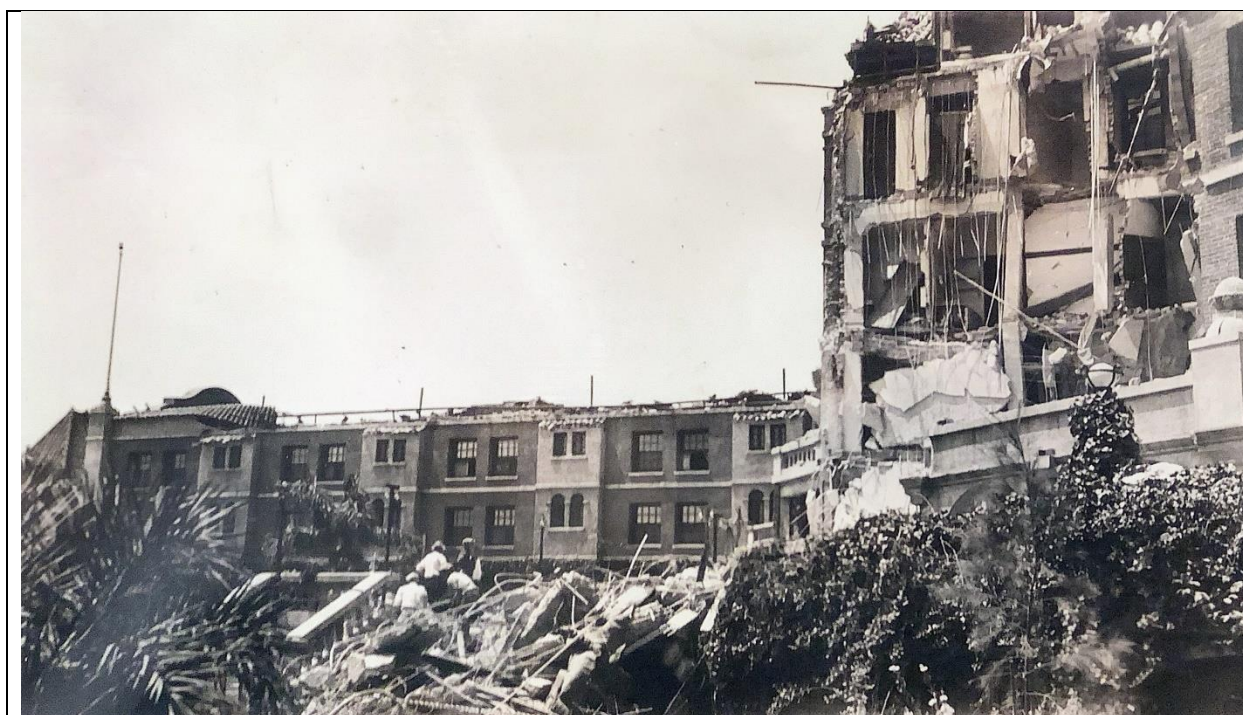
The gardener of the Arlington Hotel (Figure 1) was working close to the hotel when the earthquake hit (The Morning Press, June 30, 1925). He looked up to see the wall crack and open up about halfway up the building. Suddenly a wall of water gushed out shoving him away from the building when the wall of the hotel collapsed (Figures 17, 18, and 19). A woman, Mrs. Charles E. Perkins and the son of G. Allen Hancock, Bertram Hancock, 21, were killed as the southeastern wall and part of the floor gave way. The hotel was constructed with brick and wood frame which was veneered with brick, reinforced concrete frame of beams and columns

(Dewell and Willis, 1925). The appearance of the hotel was to render an impression of massiveness at a minimum cost. The central section of the hotel was severely damaged which collapsed completely. The failure of this structure, referred to as pretentious by the engineering committee, was attributed to the general plan of the building and torsional strains, and the placing of the water tower on the roof. The committee declared that the principles of safe construction were abandoned and the design disregarded the earthquake risk which characterized architectural and engineering practices at the time (Dewell and Willis, 1925).

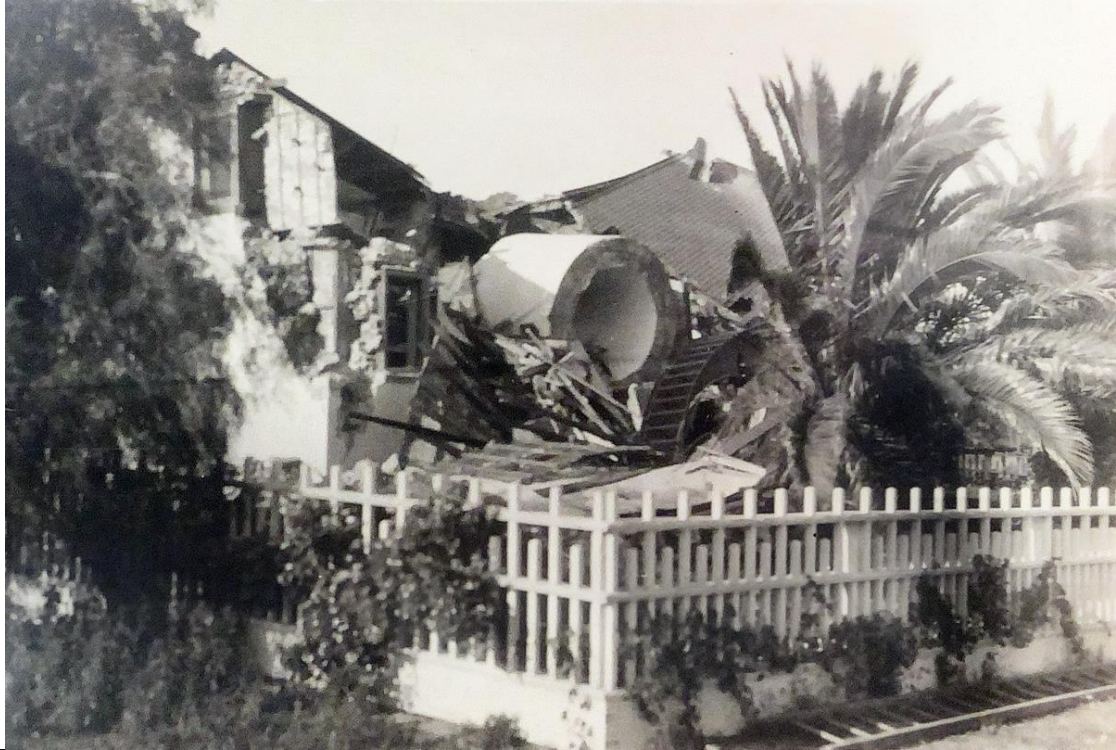
The Santa Barbara lighthouse collapsed and was the oldest landmark of the Pacific Coast at the time (Figure 20; The Morning Press, July 1, 1925). The lighthouse was located on the blufftop on the Mesa just west of Santa Barbara Point (Figure 1). The keeper of the lighthouse, Mrs. H. A. Weeks, described the lighthouse as badly damaged in the first shock, and she remained inside with her children. However, they rushed out when the second shock occurred which caused the light tower to collapse and destroy the lighthouse (Figure 20).

Figure 20. View of the collapsed lighthouse tower that crushed the home of the light keeper. Photo credit: Santa Barbara Historical Museum, Gledhill Library.

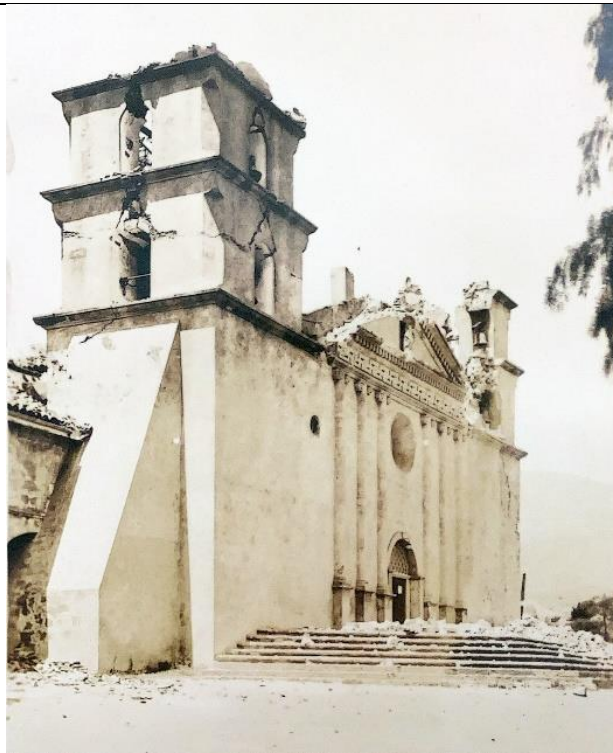
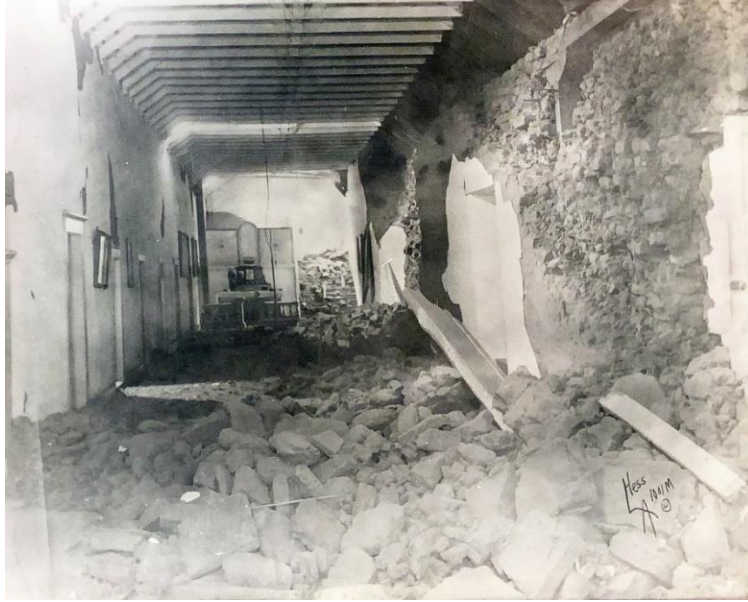
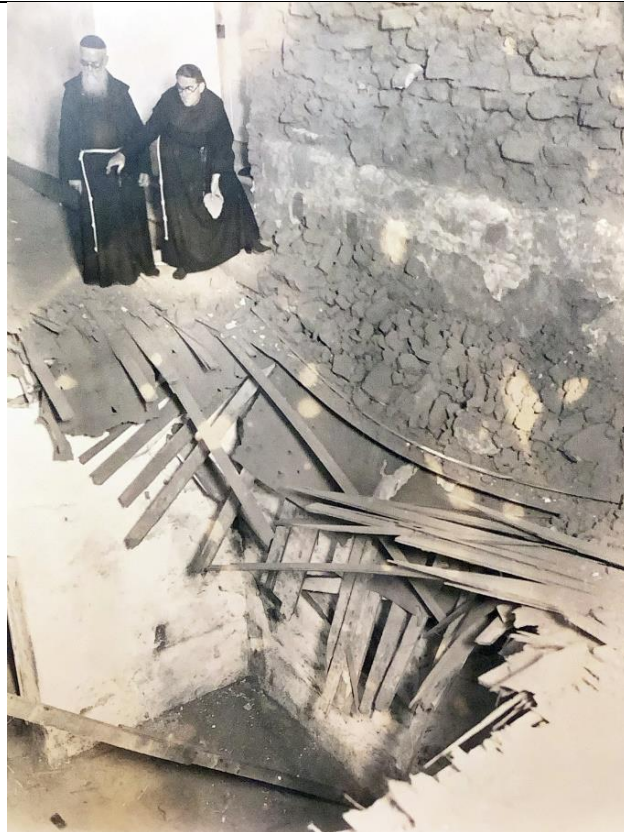
Figure 23. View of the floor collapse where Father Augustine and Brother Odoric had fallen through the floor. Photo credit: Santa Barbara Historical Museum, Gledhill Library.

collapsed before him, but both were uninjured. Father Augustine carried him outside and as roof and floor collapsed (Figures 21, 22, and 23). The neighboring three-story St. Anthony's Seminary suffered moderate damage (Figure 24).

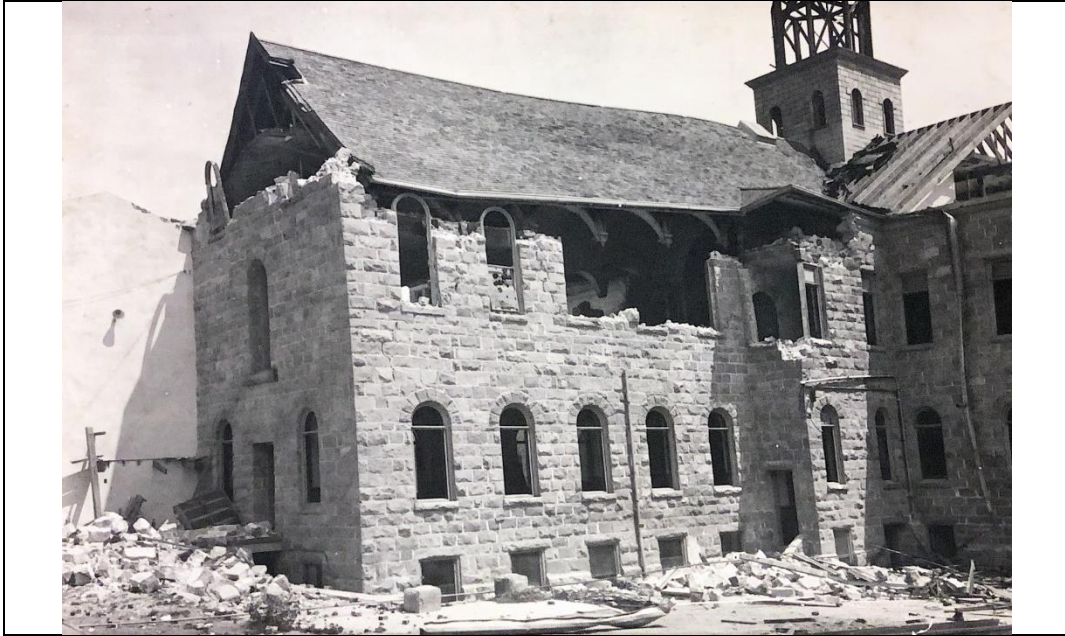
Figure 24. The sandstone masonry of St. Anthony's Seminary was damaged, and portions of the wall collapsed. Photo credit: Santa Barbara Historical Museum, Gledhill Library.

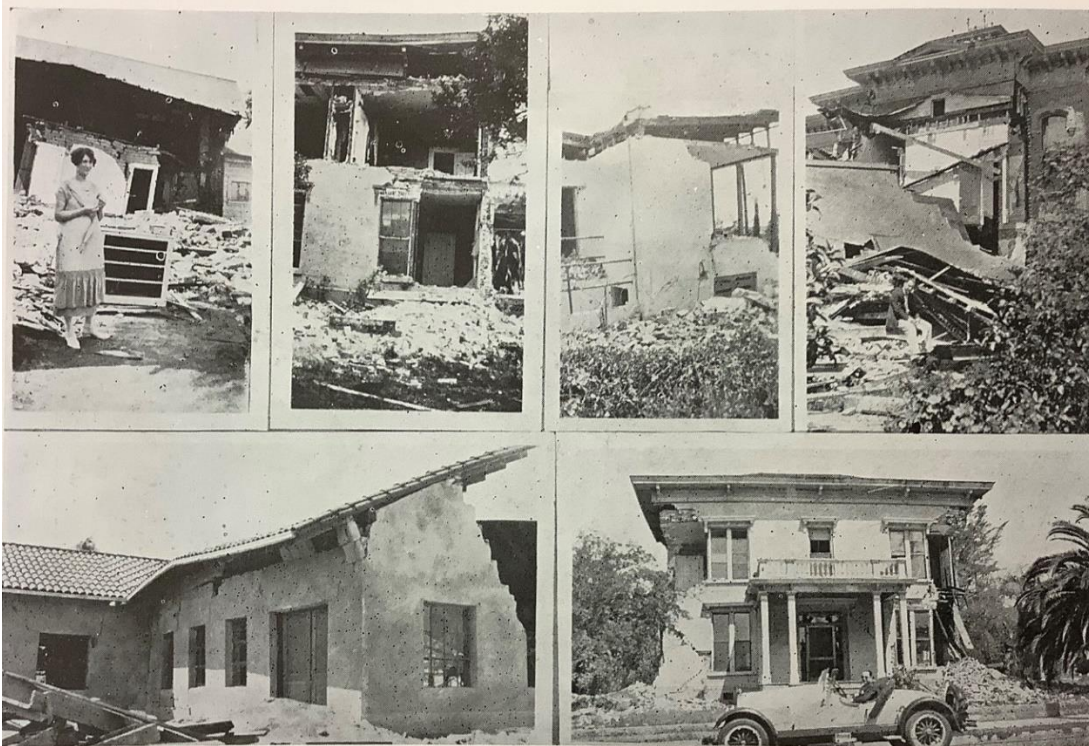
SOME OF THE 5000 HOMES DAMAGED IN QUAKE

Upper Row, Left to Right—Home at corner of W. Ortega and De la Vina. Home at corner of Victoria and Santa Barbara. Corner of cottage of Superintendent Black at General Hospital. Senator Greenwell home at Montecito and Bath.

Figure 25. A few of the damaged homes located on the west side and east side of town. Photo credit: Santa Barbara Historical Museum, Gledhill Library.

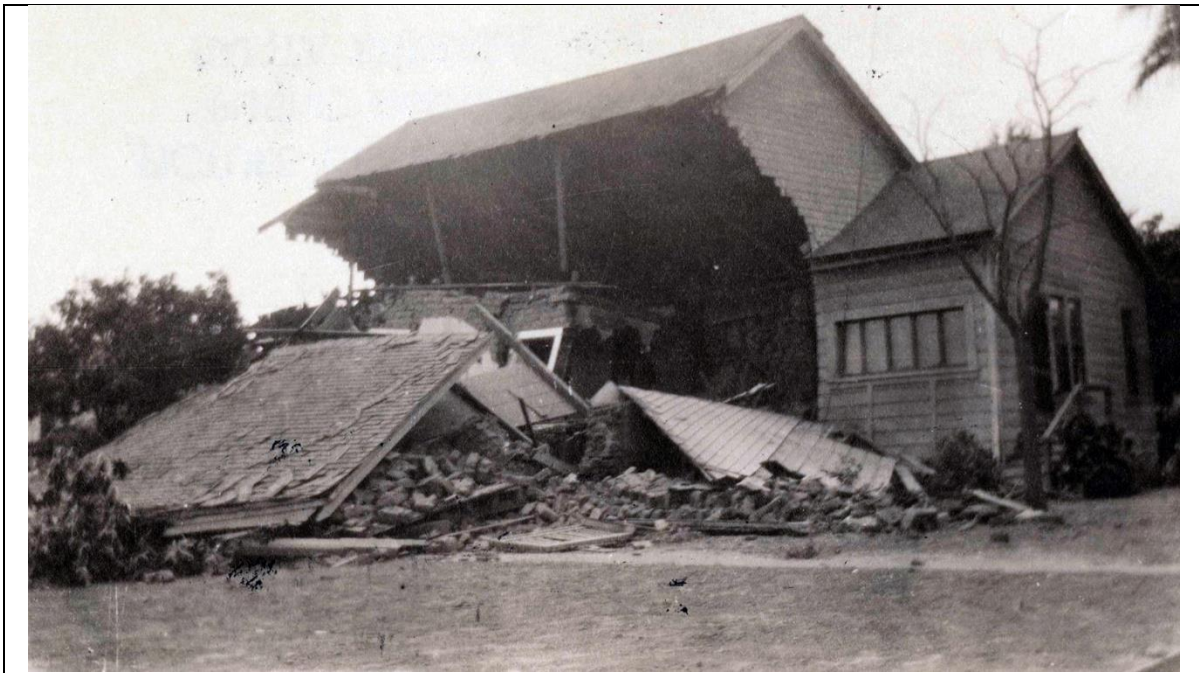
One partially collapsed home was located at 119 West Haley Street where a resident could not exit his house because the house was twisted off the foundation. (The Morning Press, June 30, 1925). A neighbor tore the wall down as the resident was trapped in his bedroom, and when the neighbor called out to him, another aftershock occurred and shifted his home further off the foundation. The Loomis House, located at 1625 De La Vina Street, was an adobe and wood frame structure that was severely damaged (Figure 26).

Figure 26. The destruction of the Loomis residence on De La Vina Street. Photo credit: Santa Barbara Historical Museum, Gledhill Library.

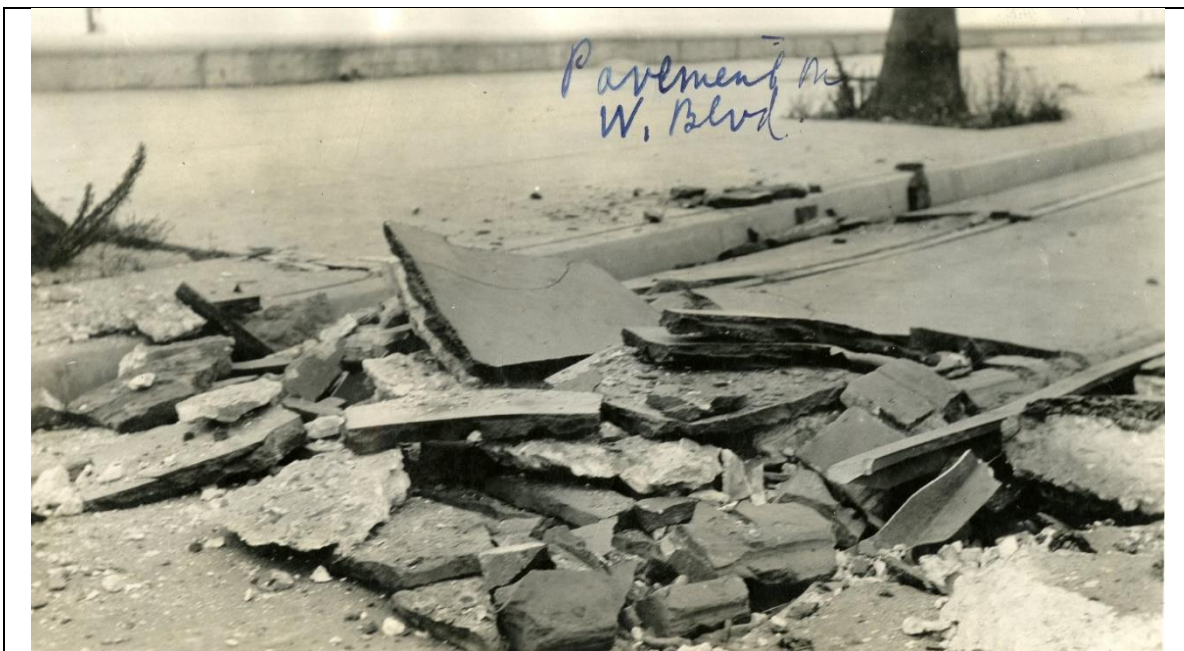
Figure 27. Broken pavement and trolley tracks on West Cabrillo Boulevard. Minor buckling of the gutter along the southeastern side of the road can be seen in the upper right of the photograph. Photo credit: Courtesy of the Edson Smith Photo Collection, Santa Barbara Public Library.

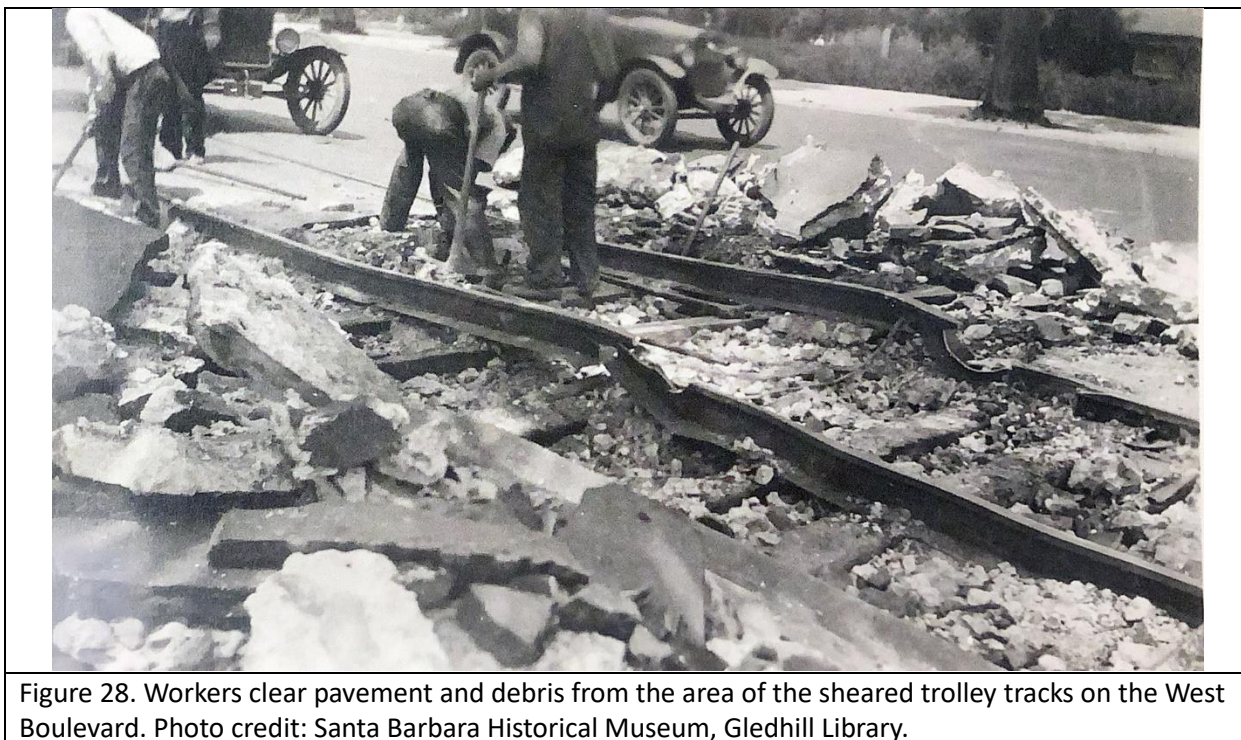
Figure 28. Workers clear pavement and debris from the area of the sheared trolley tracks on the West Boulevard. Photo credit: Santa Barbara Historical Museum, Gledhill Library.

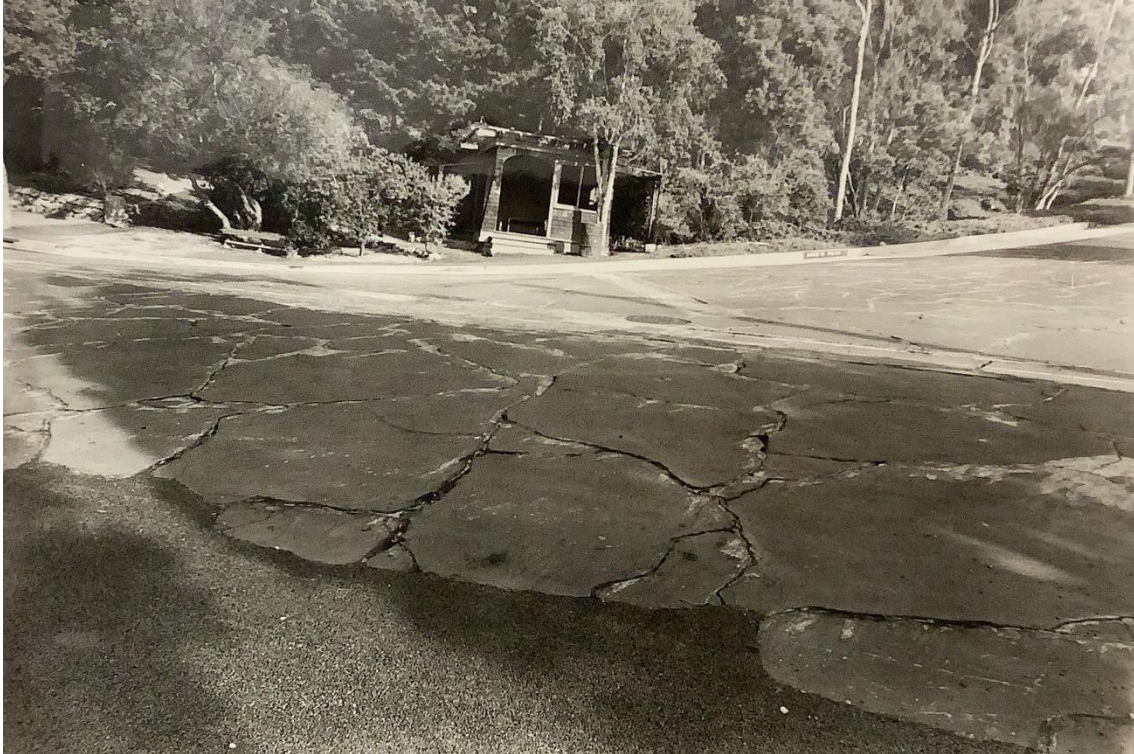
Figure 29. Uplifted and buckled road surface near the Santa Barbara waterfront. Photo credit: Santa Barbara Historical Museum, Gledhill Library.

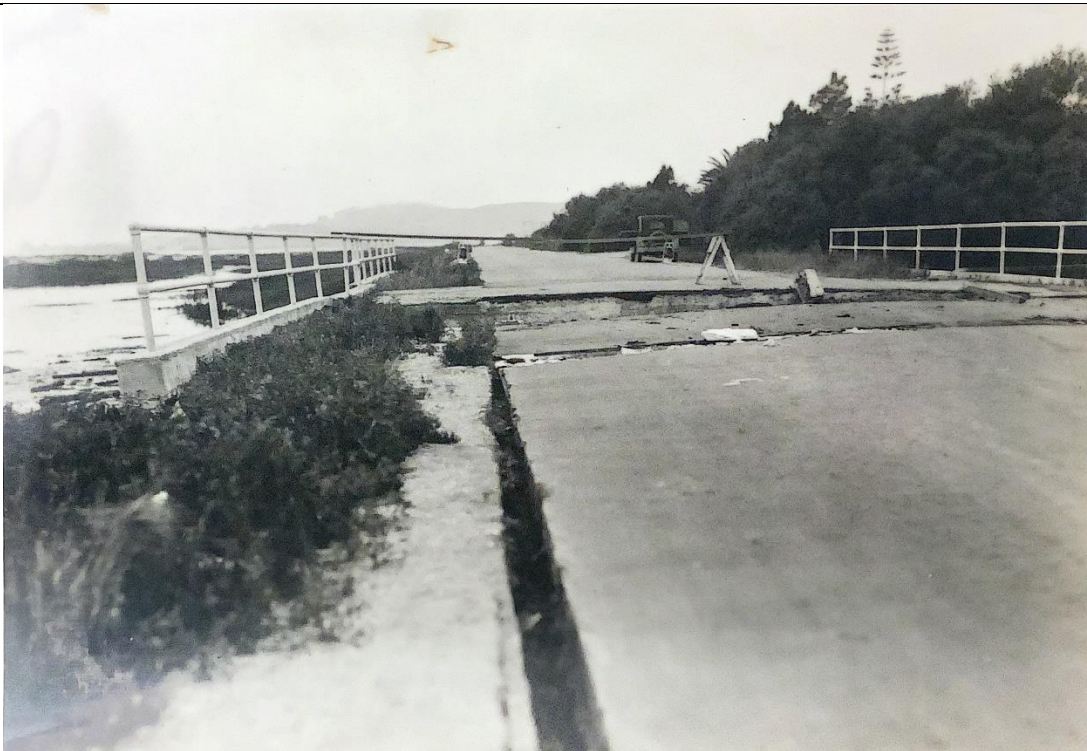
Figure 30. Displaced road on the Boulevard along the beach as the result of subsidence. The road is offset one to two feet. Photo credit: Santa Barbara Historical Museum, Gledhill Library.
