# Commemorating the 100-Year Anniversary of the June 29, 1925 Santa Barbara Earthquake

*What We Learned After the Shaking Stopped*

Larry D. Gurrola, Ph.D.

*June 9, 2025*

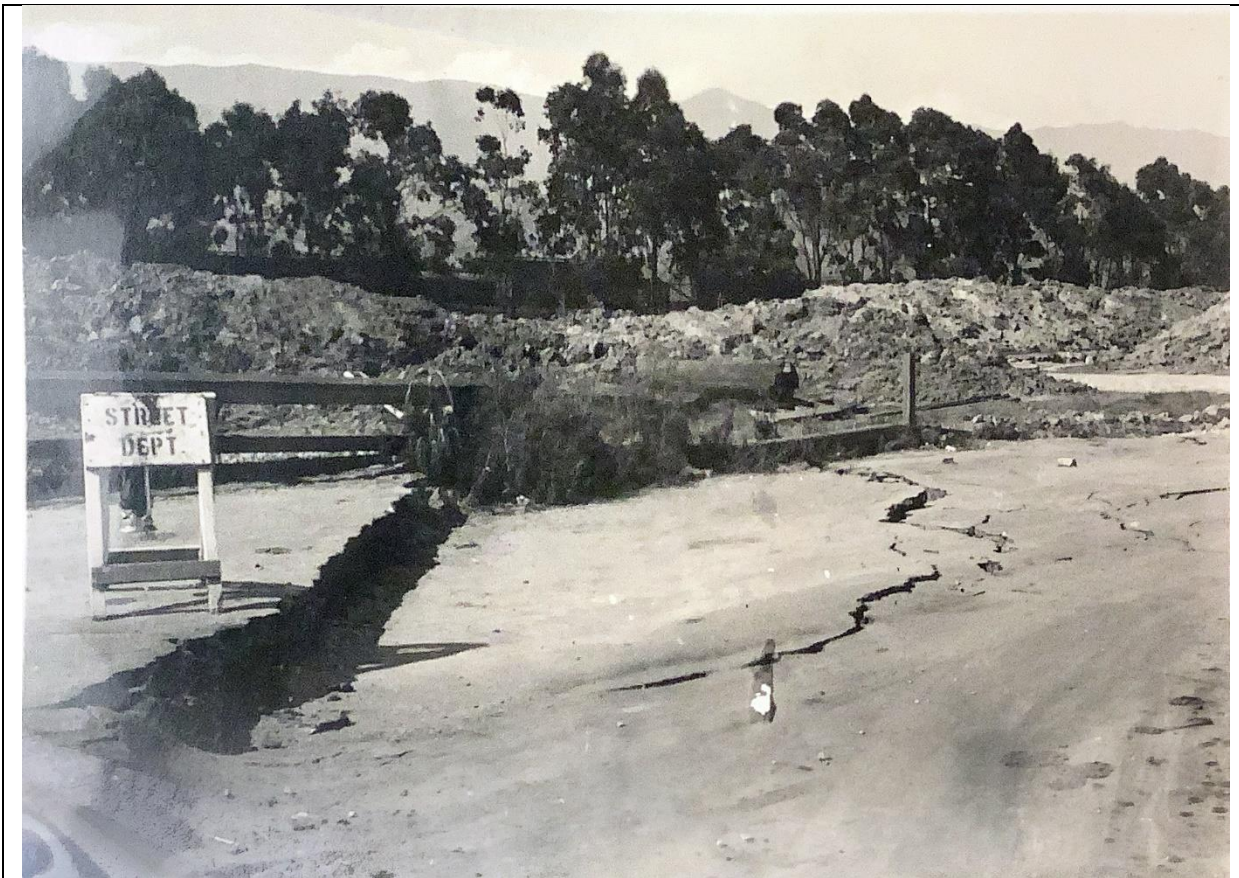
Figure 31. Displaced and tilted road surface produced by subsidence in Santa Barbara, however the specific location is unknown. Photo credit: Santa Barbara Historical Museum, Gledhill Library.

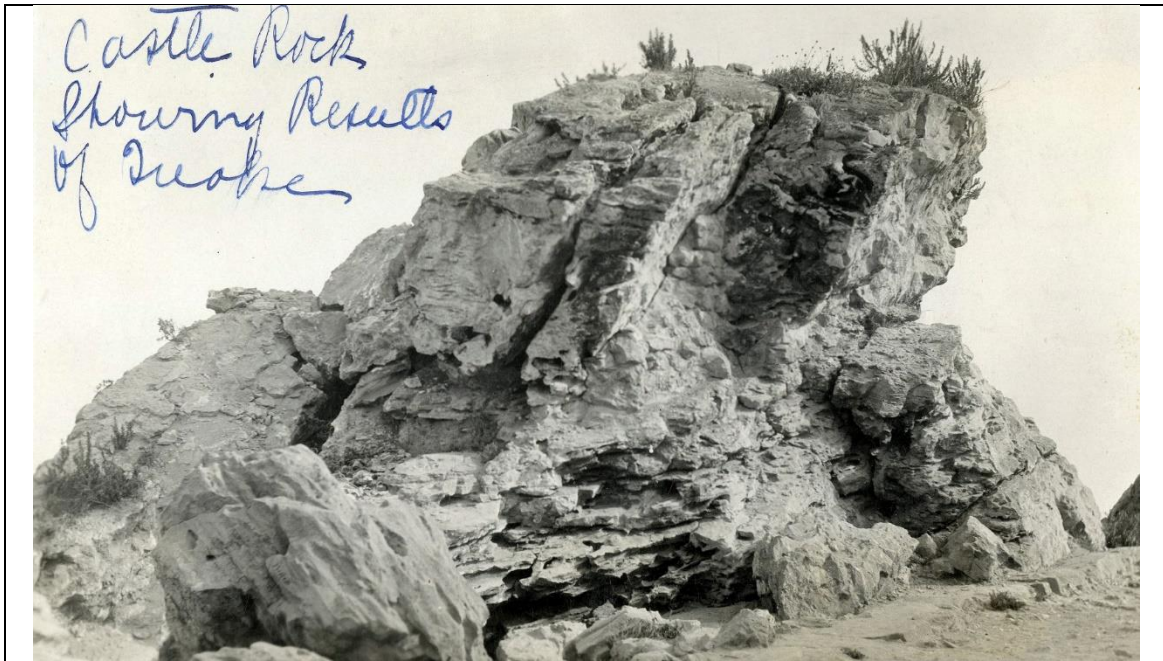
Figure 32. A rare photograph showing the resulting fractures produced by the earthquake. Photo credit: Courtesy of the Edson Smith Photo Collection, Santa Barbara Public Library.

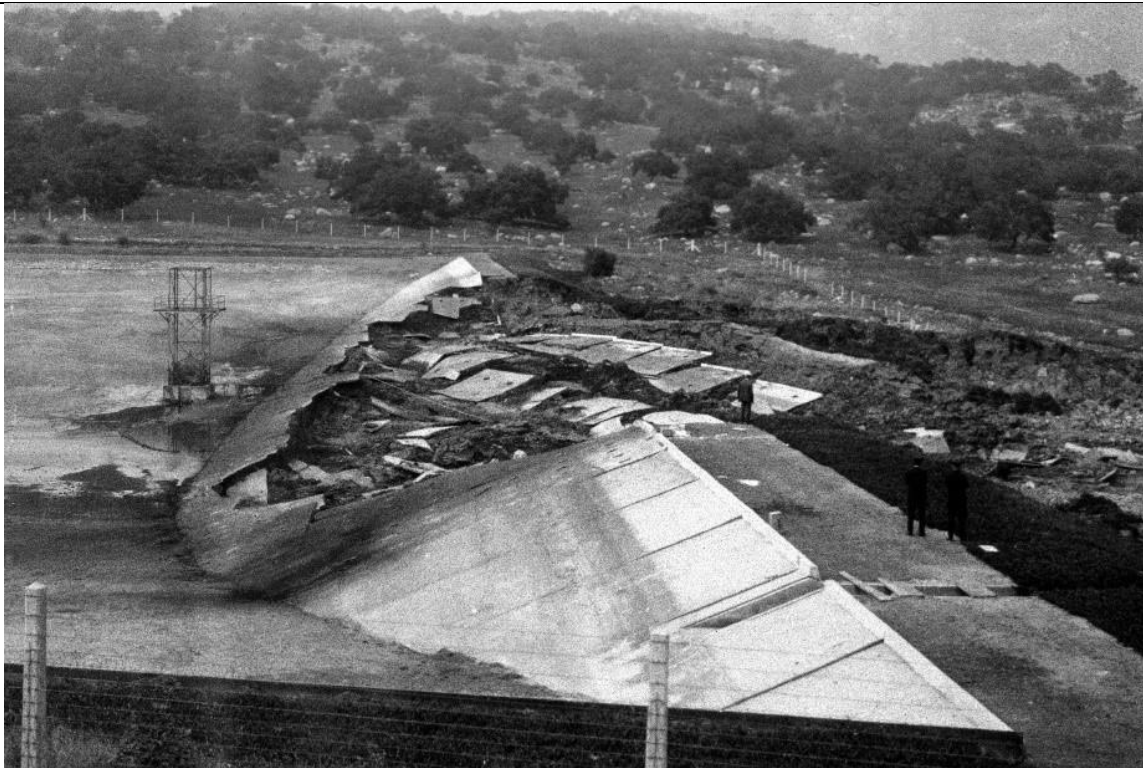
The catastrophic release of 45 million gallons of water produced an outbreak flood that tore through the mostly uninhabited Sycamore Canyon (The Morning Press, June 30, 1925). A. Cozzalio, a dairyman working in the canyon, attempted to escape the outbreak flood. When he reached the Alisos Creek bridge, he had to scamper up the slope to safety but the raging torrent as he described, carried his auto out to sea by a wall of water twenty feet (6 m) high (American Autochrome Co., 1925). The flood uprooted trees, mud, boulders, and masses of kindling, and after exiting the mouth of Sycamore Canyon, the flood rushed down a natural gully between Voluntario Street and Aliso Street (Figure 1; Easton, 2000). The outbreak flood then carried off three houses and dumped them on the banks at Cacique Street and damaged several others.

Figure 33. Close up view of the dam after the landslide failure of the earthen dam. Photo credit: California Department of Dam Safety Archives in Association of State Dam Safety Officials.

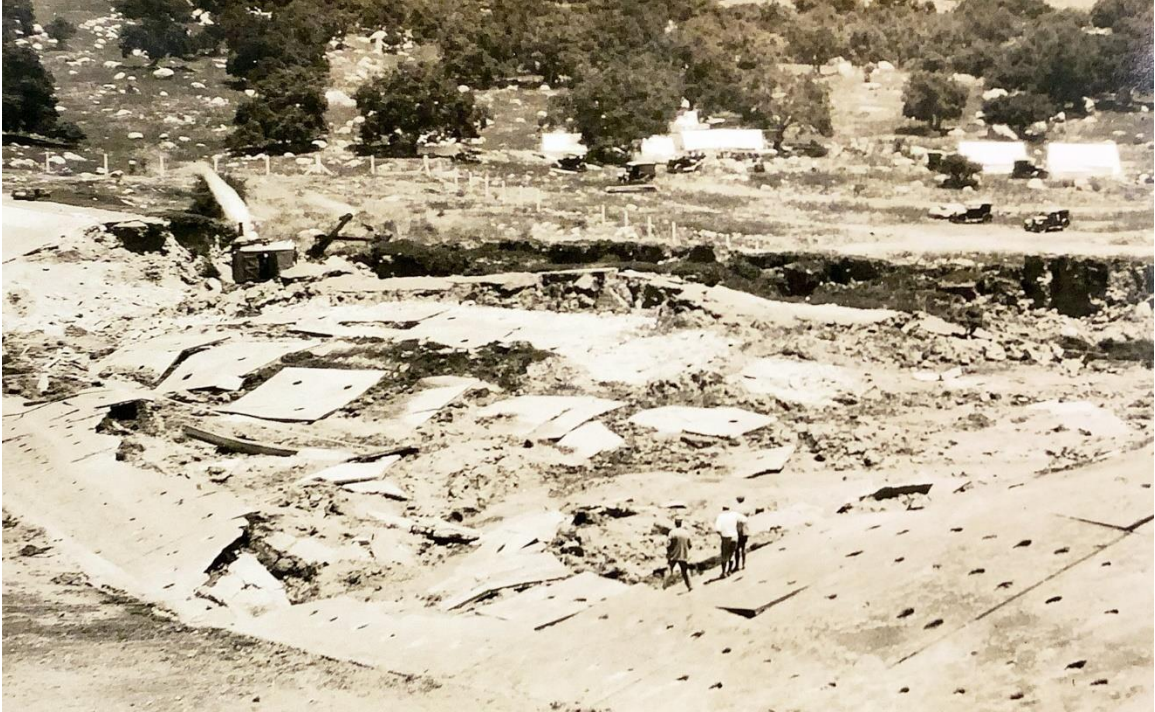
Figure 34. Wide angle perspective looking at the drained reservoir (left of dam) and the landslide formed on the earthen dam. Photo credit: California Department of Dam Safety Archives in Association of State Dam Safety Officials.
