# Commemorating the 100-Year Anniversary of the June 29, 1925 Santa Barbara Earthquake

*What We Learned After the Shaking Stopped*

Larry D. Gurrola, Ph.D.

*June 9, 2025*

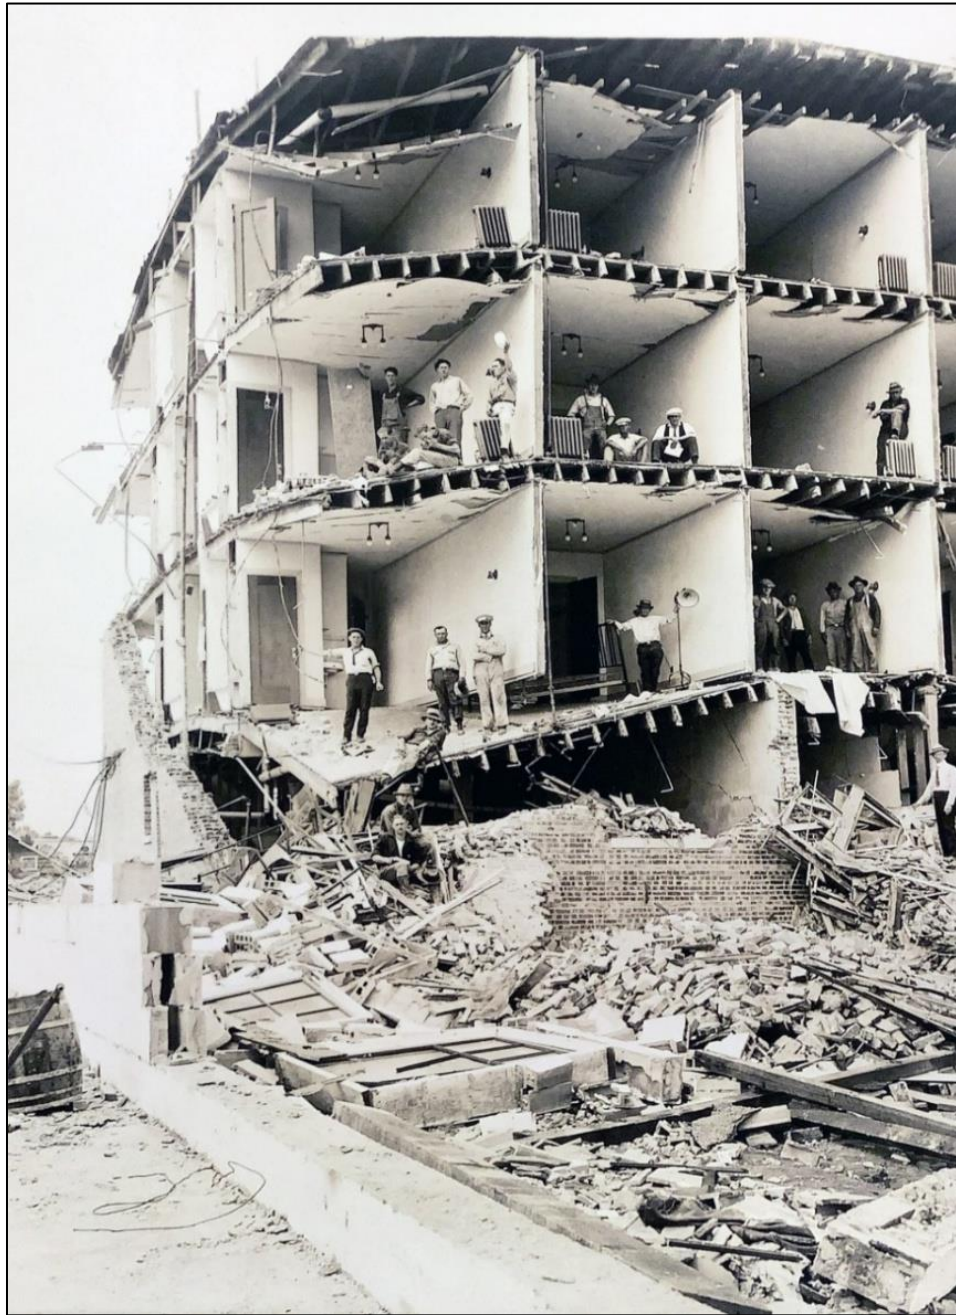
Cover page: An entire outer wall of the Hotel Californian collapsed due to strong shaking. The hotel was located on lower State Street at the intersection of East Mason Street, one block away from the beach. Photo credit: Santa Barbara Historical Museum, Gledhill Library.

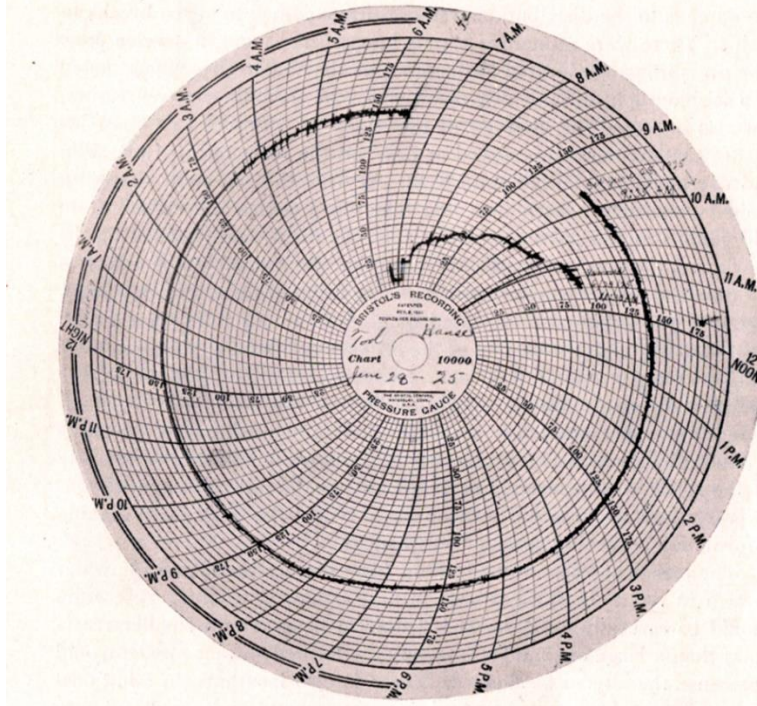
later became aware that small tremors had caused disturbances of the water pressure gauge beginning at 3:27 a.m. (Figure 2), and they repeated at intervals up until the main shock at 6:42 a.m. The swarm of several hundred tremors were small foreshocks that did not wake him or other residents in the city. These tremors were also evident on the thermometer gauge recording at the Southern Counties Gas Company which was located at the southwest corner of Montecito Street and Quarantina Street (Figures 1 and 3). These foreshocks were the first manifestation that something bigger would shake the community of Santa Barbara.

Figure 2. The needle that recorded the water pressure shows an abrupt displacement at 6:42 a.m. Prior to the main event, the graph shows that the needle was jostled at 3:27 a.m. by the initial foreshock (Nunn, 1925). Scientist later determined that a swarm of minor foreshocks followed the first foreshock, possibly up to several hundred small earthquakes (Olsen and Sylvester, 1975).

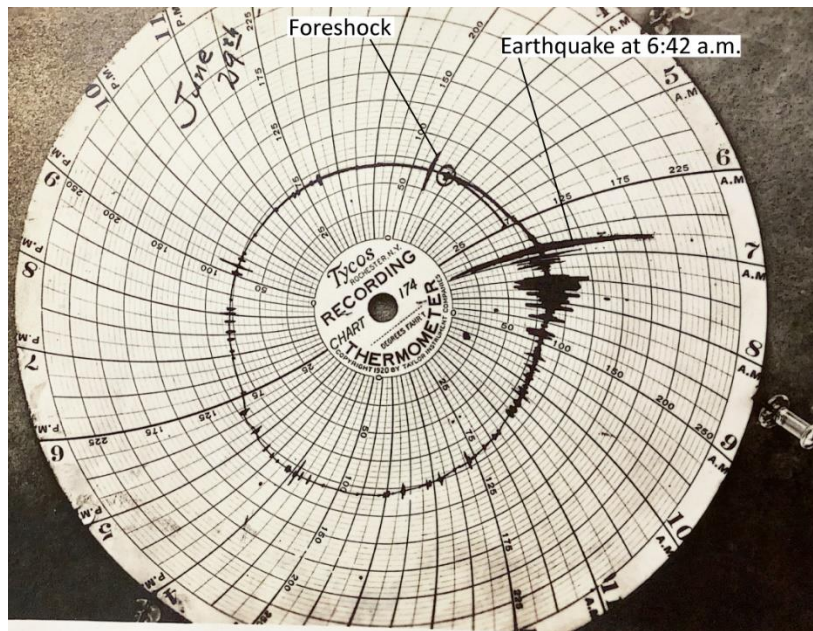
Figure 3. The temperature gauge recording of the Southern Counties Gas Company recorded the foreshock at 3:27 a.m. and the main shock at 6:42 a.m. Photo credit: Santa Barbara Historical Museum, Gledhill Library.

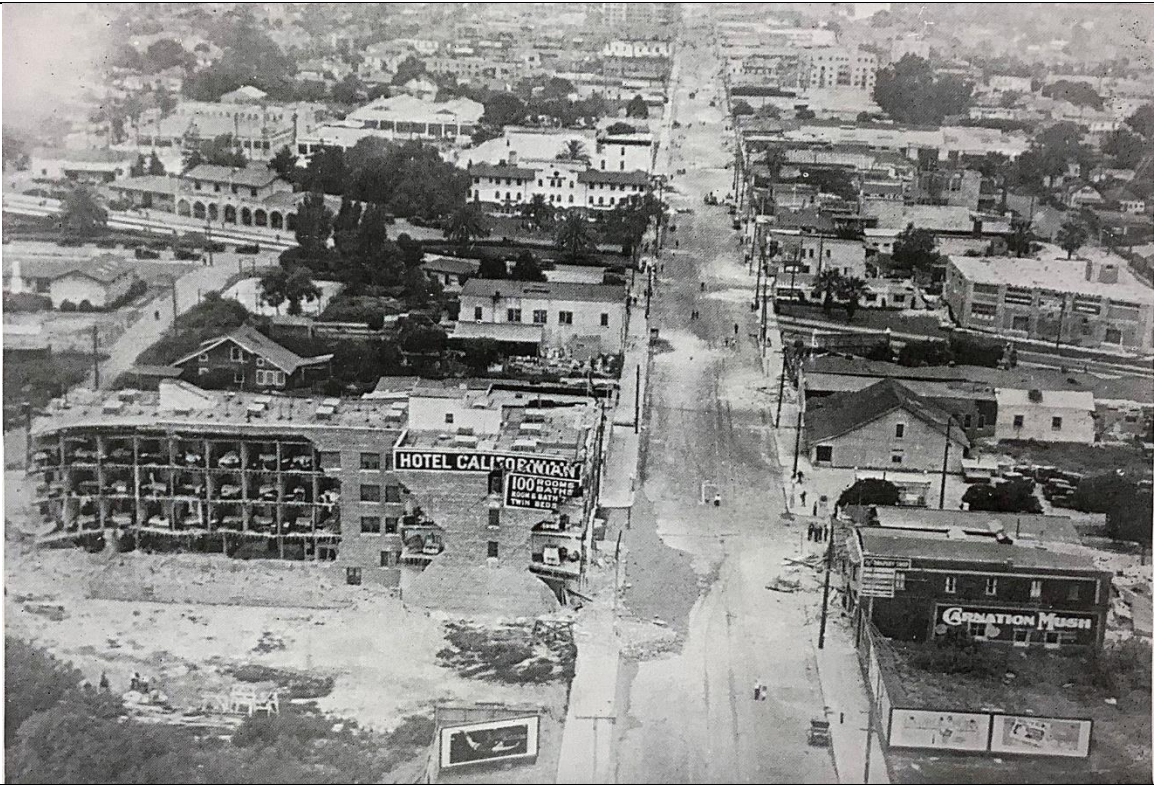
Figure 7. Aerial view of the lower State Street business district. The view is looking up State Street from the waterfront. Photo credit: Santa Barbara Historical Museum, Gledhill Library.

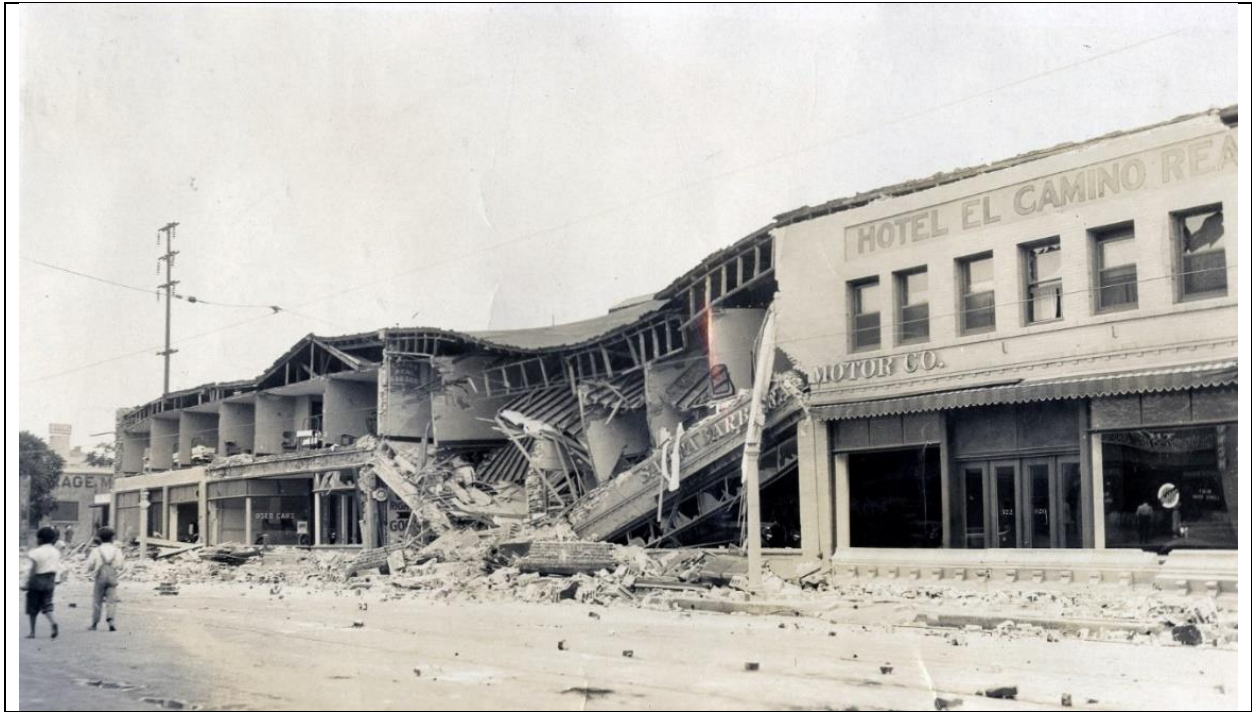
A lodger at the El Camino Real Hotel (Figure 10), George Miller, was shaken out with his bed and fell on a wall which had already collapsed onto State Street and he only suffered cuts and bruises (The Morning Press, June 30, 1925). The hotel was located at 318 State Street.

Figure 10. View of the El Camino Hotel located at 318 State Street on the northeast side of the street. Photo credit: Santa Barbara Historical Museum, Gledhill Library.

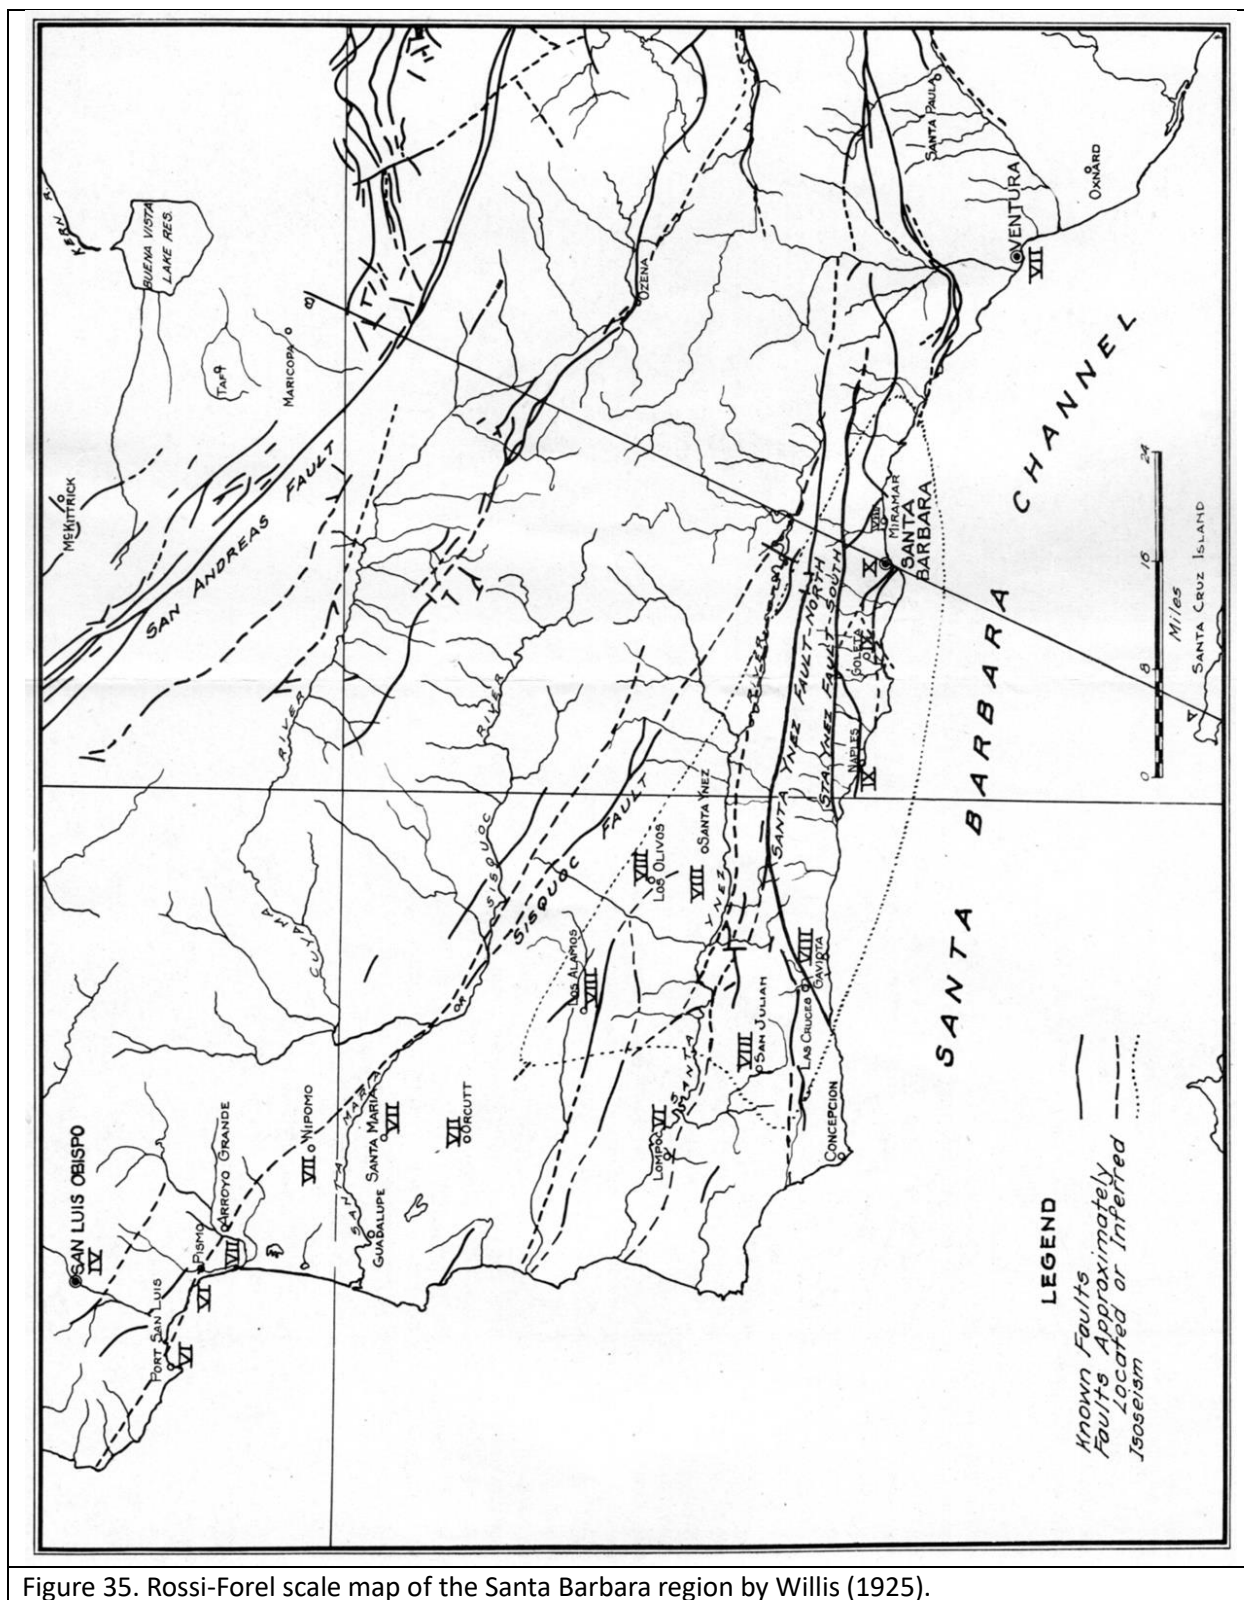
Past studies have assigned site intensities using the Rossi-Forel scale and Willis (1925) assigned an intensity of X (Figure 35) to the Santa Barbara area (Table 1) whereas Olsen and Sylvester (1975) assigned a maximum Modified Mercalli intensity of IX for some areas of Santa Barbara (Table 1, Appendix A). They noted that shaking intensities were greatest in the southeastern portion of the city and along the base of Mesa in the lower west side of the city. A regional isoseismal map was produced by Topozada and Parke (1975) and they assign Modified Mercalli intensities of VIII-IX for the Santa Barbara area (Figure 36). Hough and Martin (2018) produced a detailed analysis of shaking intensities for the city of Santa Barbara with most intensities ranging from VII-IX and another of the Santa Barbara and Goleta areas (Figure 37). The higher intensities may be associated with seismic amplification in unconsolidated alluvium and estuarine deposits.

Figure 35. Rossi-Forel scale map of the Santa Barbara region by Willis (1925).

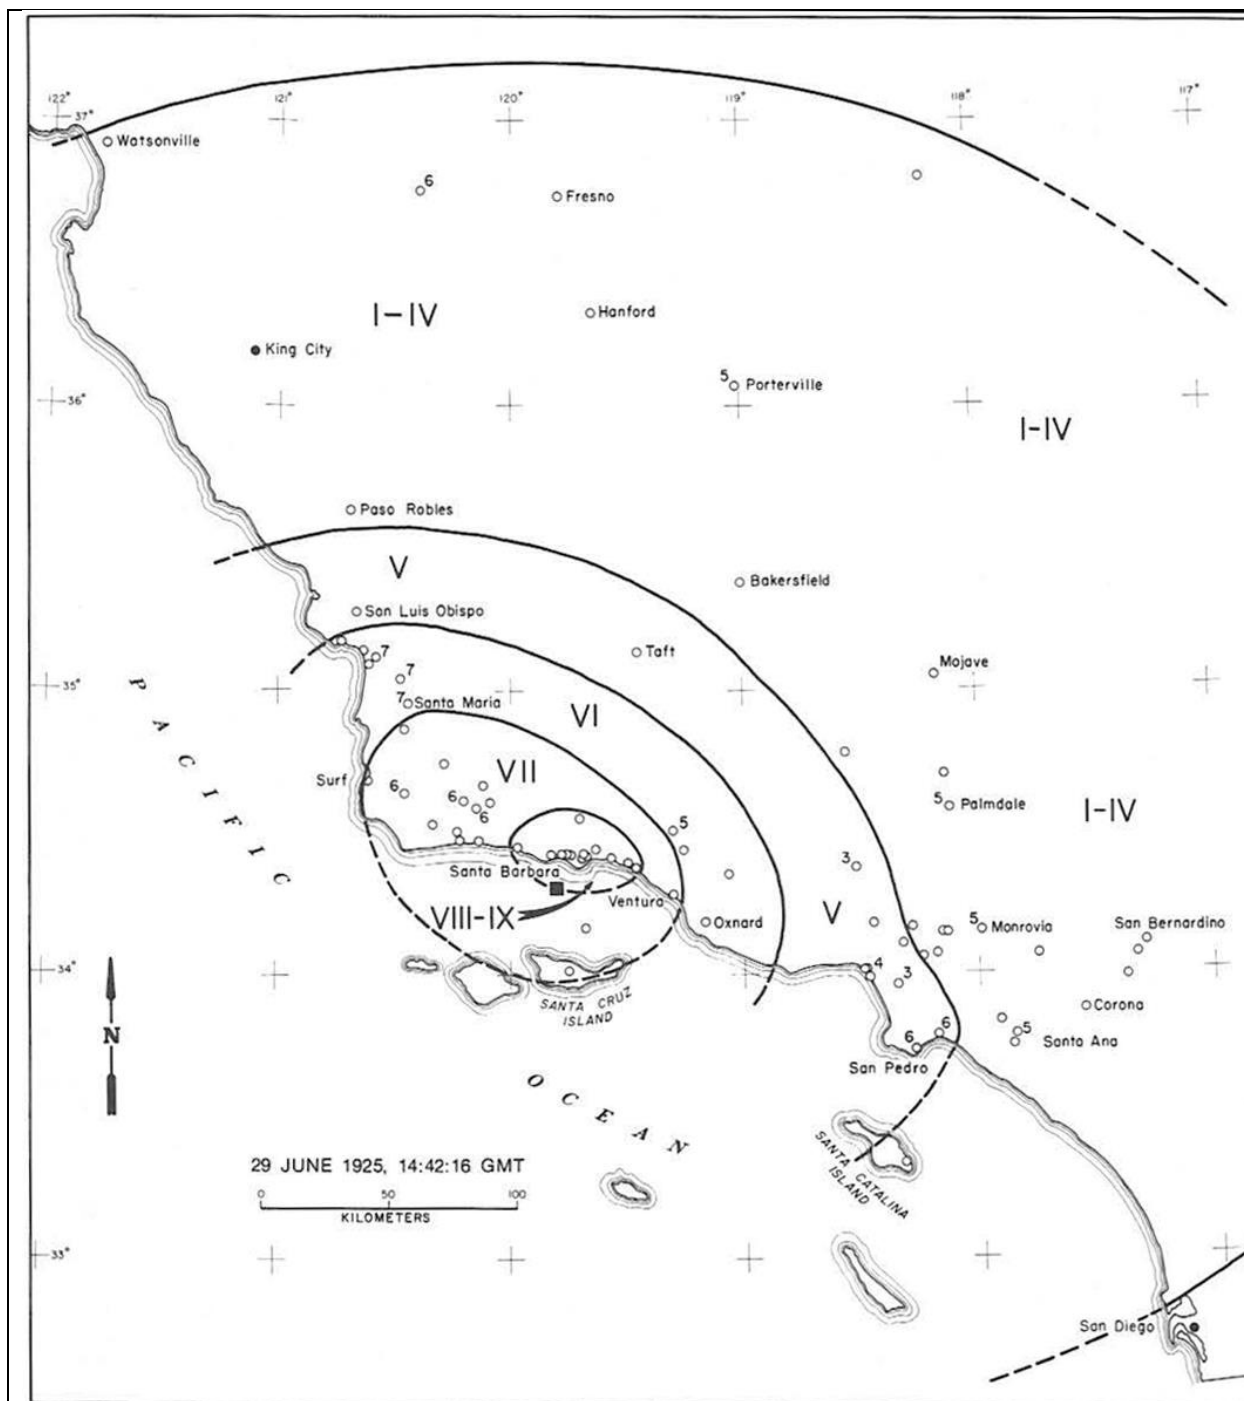
Figure 36. Isoseismal map of the June 29, 1925 earthquake by Toppozada and Parke (1975). Used with permission from the California Geological Survey, California Geology.

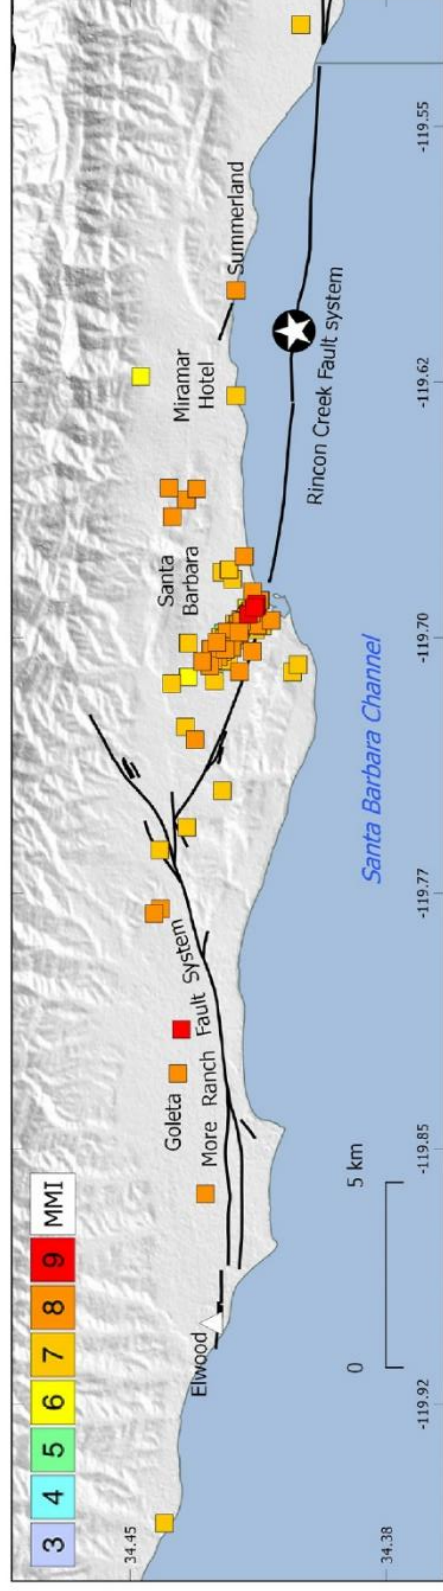
Figure 37. Modified Mercalli intensity map of the Santa Barbara and Goleta areas. Refer to Appendix A for an explanation of the Modified Mercalli scale. From Hough and Martin (2018).
